**Investigation of Thermal and Electrical
characteristics of crystalline silicon
Photovoltaic modules under varying
operational conditions**

Monphias Vumbugwa

Doctor of Philosophy (Physics)

to be awarded at the Nelson Mandela University

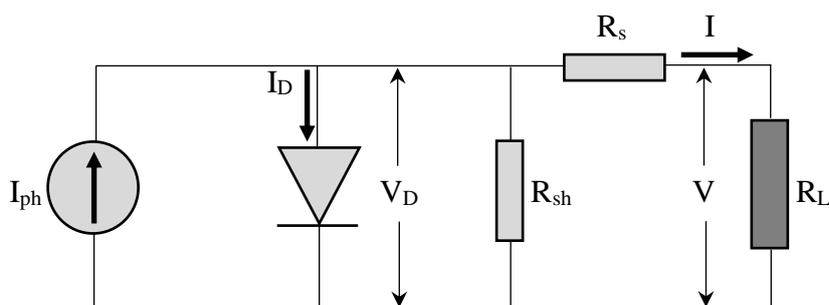
Figure 2.4: Simplified equivalent circuit of a PV cell showing parasitic series and shunt resistances, R_s and R_{sh} , respectively.

The idealized equivalent circuit of a PV cell is shown in Figure 2.4, and the source current I , which results from the excitation of electrons by the photons, flows to the external load of resistance R_L when the diode voltage is V .

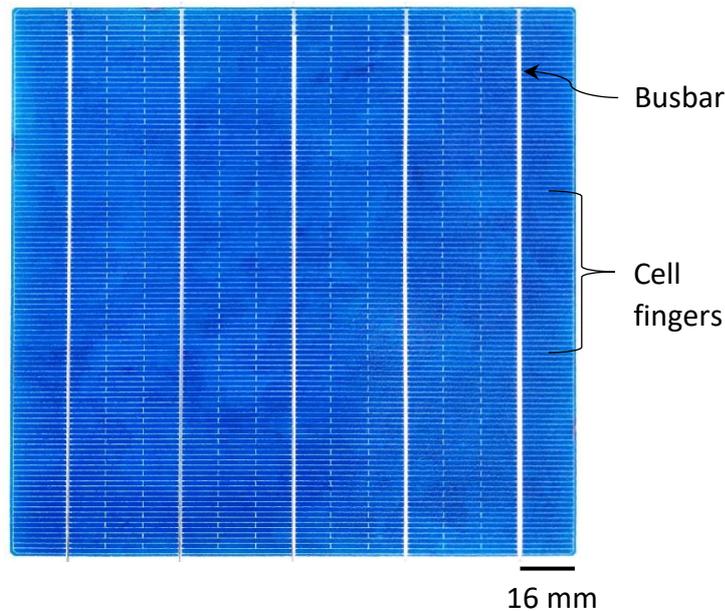
Figure 2.5: A typical polycrystalline silicon PV cell showing fingers and busbars.

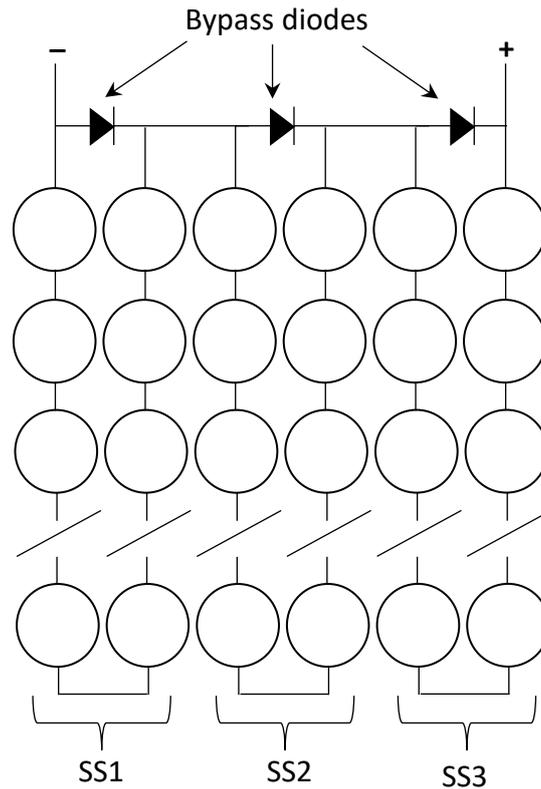
Figure 2.6: Layout of cells and bypass diodes in a crystalline silicon PV module. Each substring (SS1, SS2 and SS3) has a bypass diode in parallel to it.

PV cells generate a small amount of power, so they are often assembled and encapsulated to form PV modules that produce higher power at a desired current and voltage. The module structure differs with cell type and module application [16][26][54]. A typical crystalline PV module layout comprises 6 columns X 10 rows (or 6 x 12) of cells. Figure 2.6 shows a configuration of crystalline silicon cells and diodes in a crystalline silicon module. The cells are usually numbered from top left through the substrings SS1, SS2 and SS3 to top right.

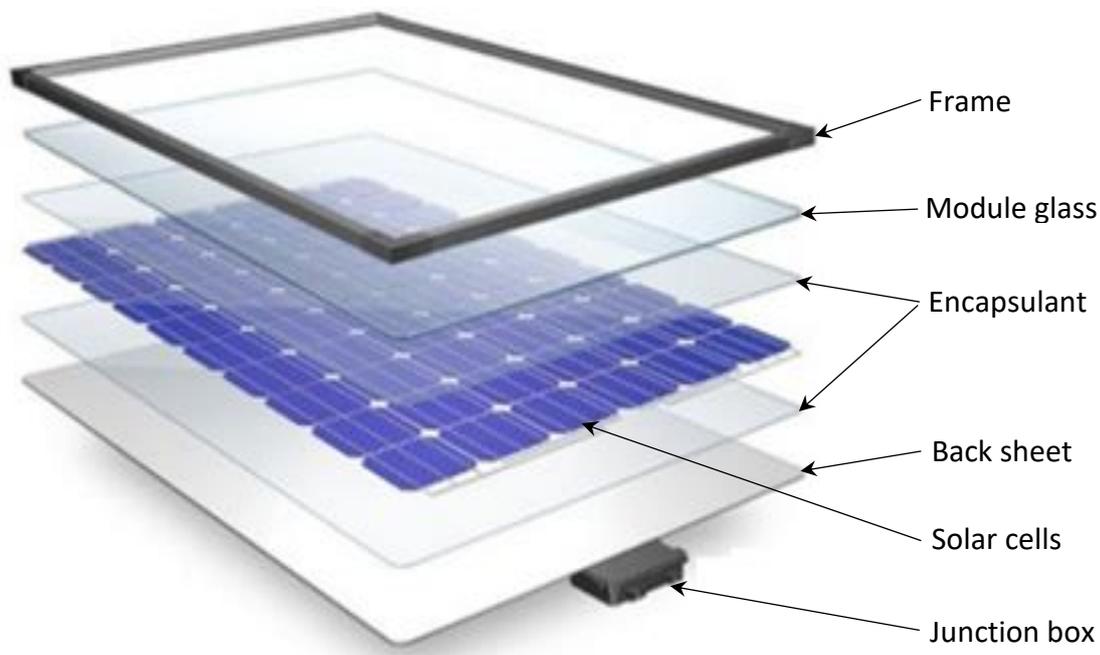
Figure 2.7: Structure of a crystalline silicon PV module [62].

Figure 2.7 shows the components which make up a PV module of crystalline silicon technology. PV cells are sandwiched between the transparent front glass and a back sheet using an encapsulant, for protection from mechanical damage and moisture ingress. The frame binds the layers to reduce flexibility and is also used for mounting purposes in the field. The junction box is a terminal point for electrical connections and contains bypass diodes.

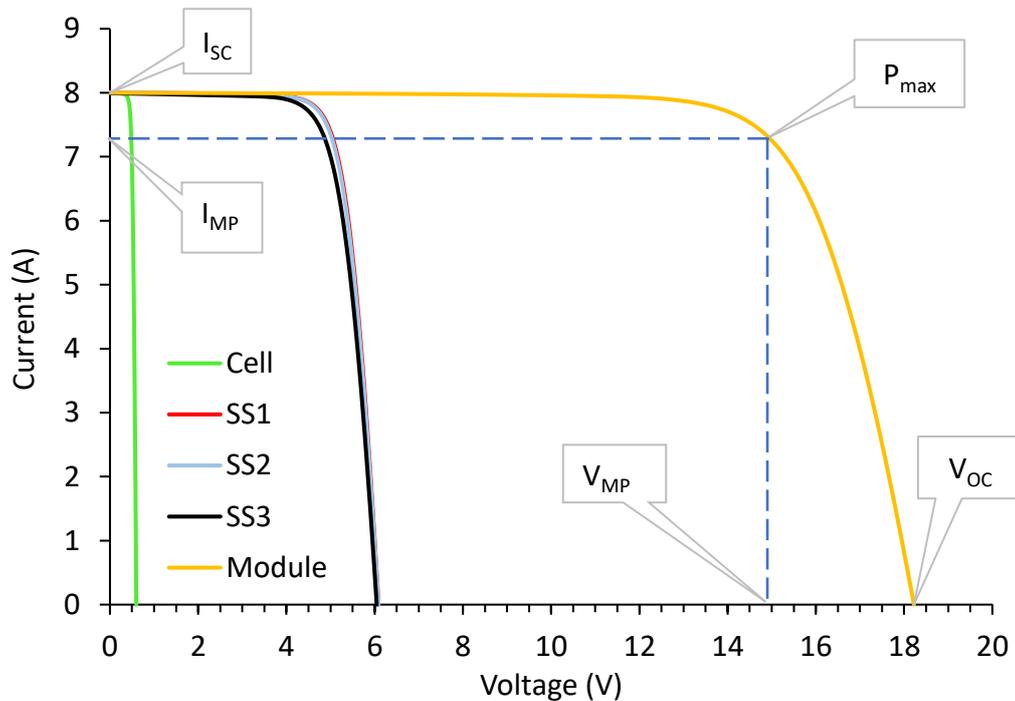
Figure 2.8: I-V curves of a cell, substrings and module simulated under standard test conditions in PVSim. The performance parameters of the module are indicated.

maximum power point, I_{MP} and V_{MP} , and the maximum power (P_{max}). The voltages of the substrings at any current value add up to give the module's voltage at that particular current, e.g., at zero amps, the V_{OC} s of the three substrings, in Figure 2.8, give the V_{OC} of the module when added. The number of cells in each substring can be obtained by comparing the V_{OC} s of the cell and the substring, and in this scenario (Figure 2.8) each substring contains 10 cells.

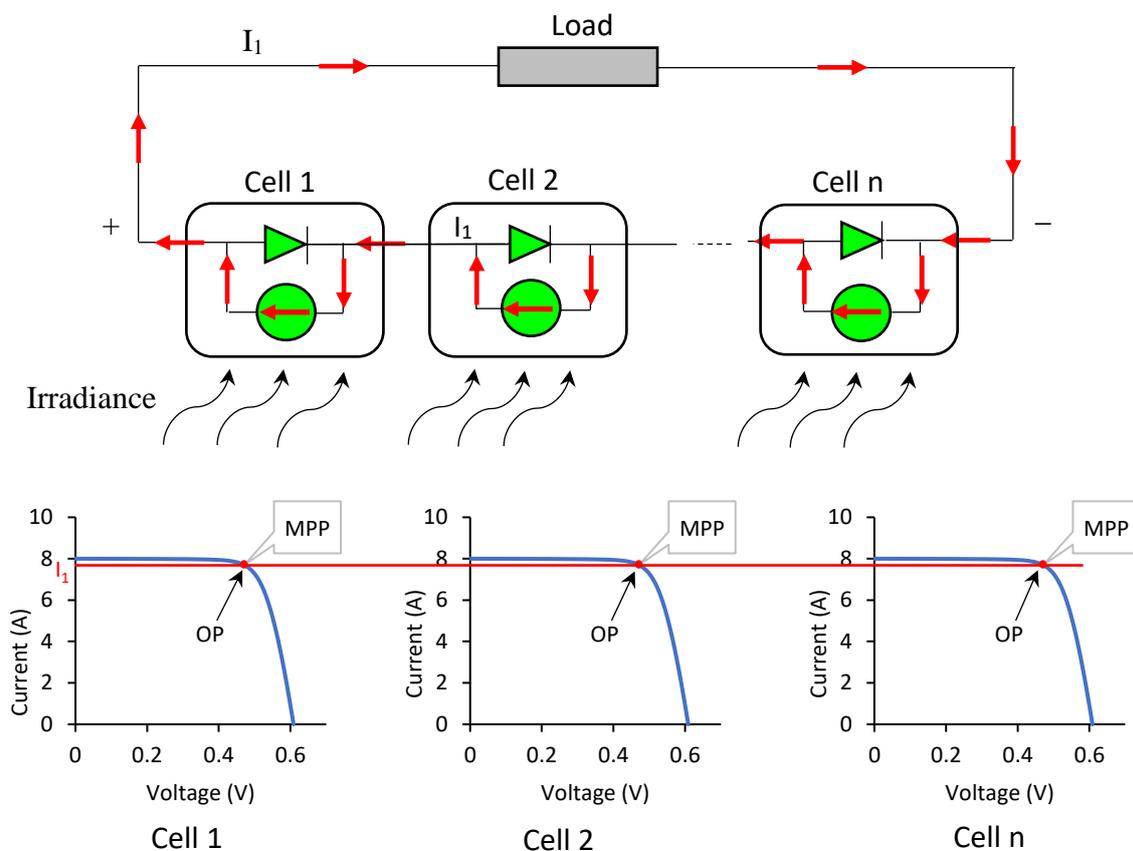
Figure 2.9: PV cells connected in series and producing equal current. The cells operate at their maximum power points (MPPs).

When a PV module is illuminated, all cells contained in the PV module must generate equal current. Figure 2.9 illustrate this phenomenon diagrammatically when the cells (cell 1 to cell n) receive equal irradiance and generate equal current (I_1). The I-V curves in Figure 2.9 show that the operating points (OP) of the cells are matched and the cells are generating current (I_1) at their maximum power point (MPP).

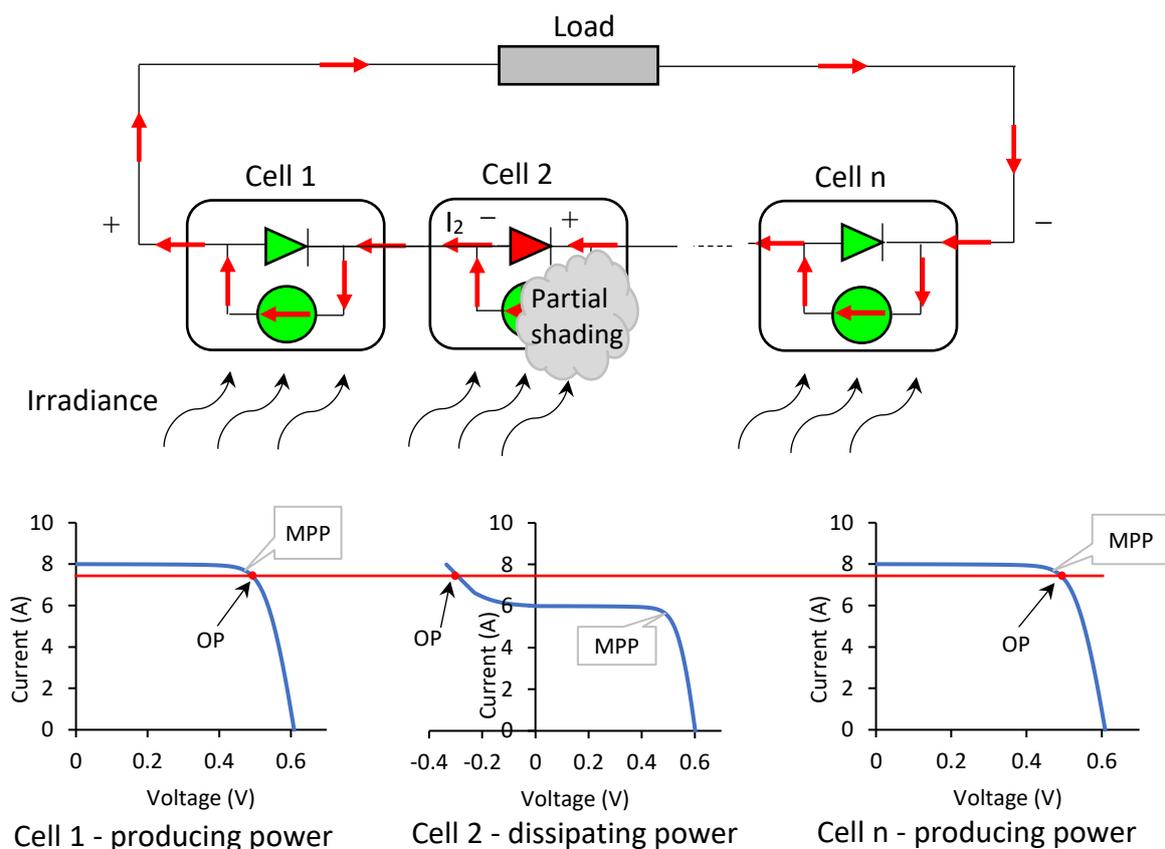
Figure 2.10: Current mismatch in substring cells due to partial shading. The I-V curves show the operating points (OPs) of the cells differ from the maximum power points (MPPs).

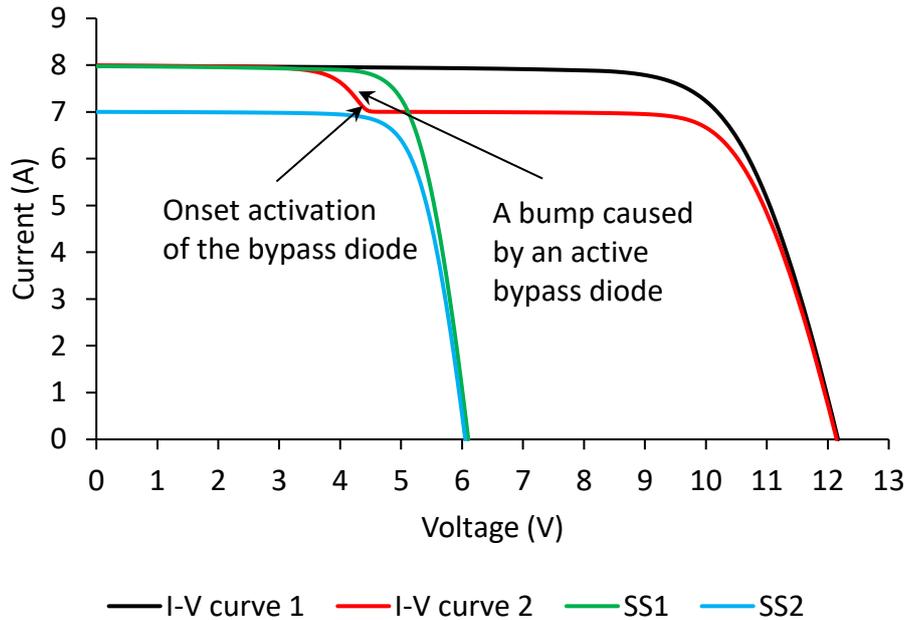
Figure 2.11: SS1 and SS2 show individual I-V characteristics of mismatched substrings, which when combined yield I-V curve 2 with a bump indicating an active bypass diode. I-V curve 1 is a combination of the substrings when they are matched, with SS2 operating normally as SS1.

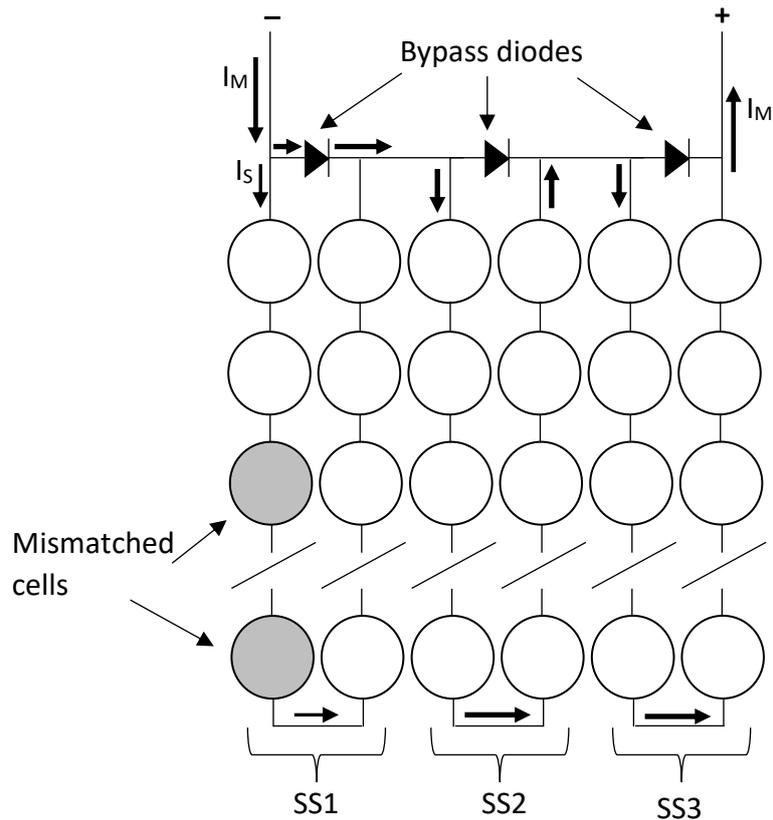
Figure 2.12: Three substrings, SS1, SS2 and SS3, containing series-connected cells and illustrating mismatch which result in the module's current (I_M) passing through the bypass diode paralleled to SS1. The substring current (I_S) is less than the module current (I_M).

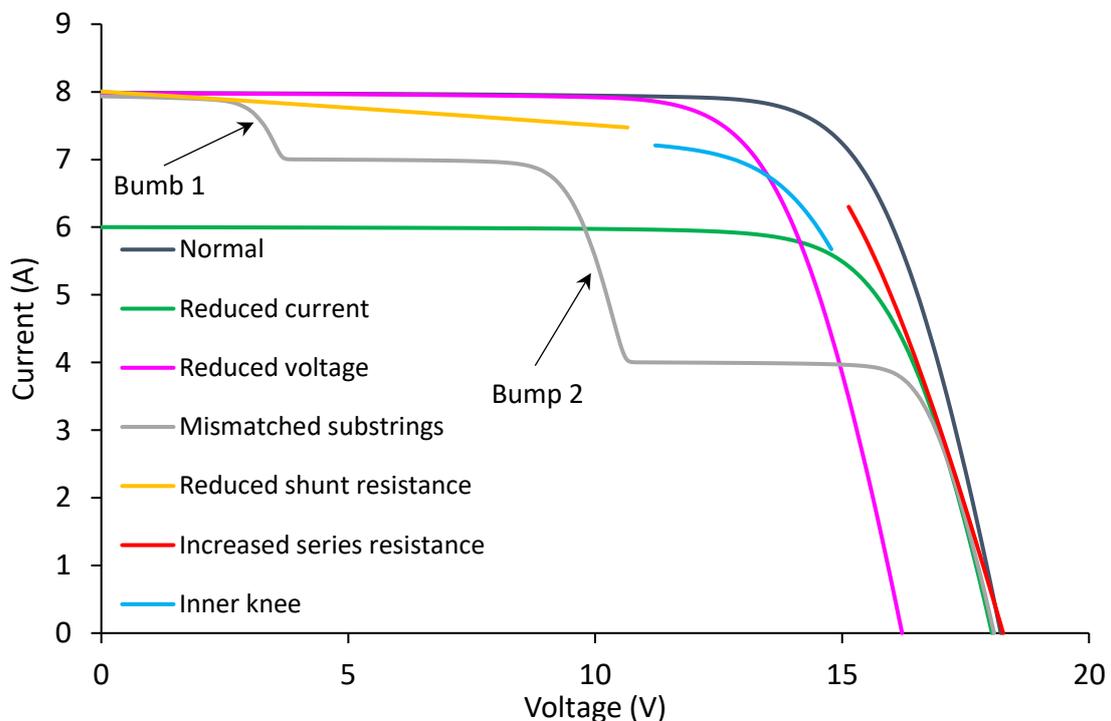
Figure 2.13: I-V curves deviate from the normal. The I-V characteristics of the PV module were simulated in PVSIM and reflect the impact of different anomalies on the I-V curves.

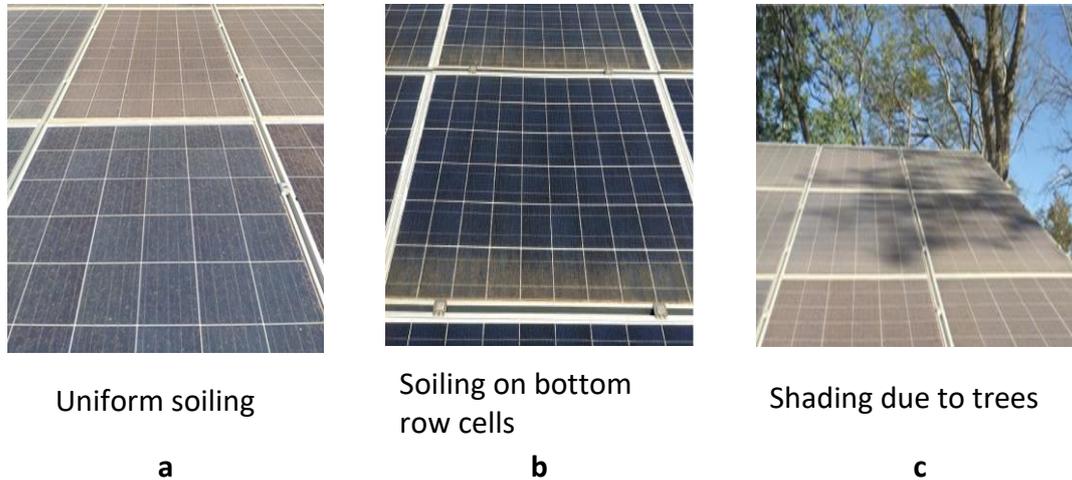
Figure 2.14: Shading on crystalline silicon PV modules.

shading on PV cells as shown in Figure 2.14 (a) and (b), respectively. Figure 2.14 (c) shows partial shading due to trees.

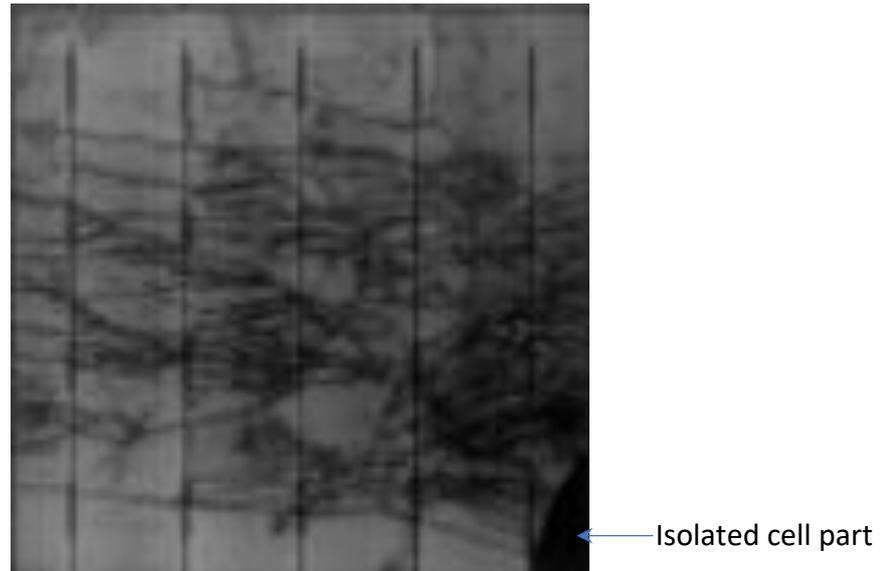
Figure 2.15: EL image of a PV cell showing isolated (dark) parts due to cracks.

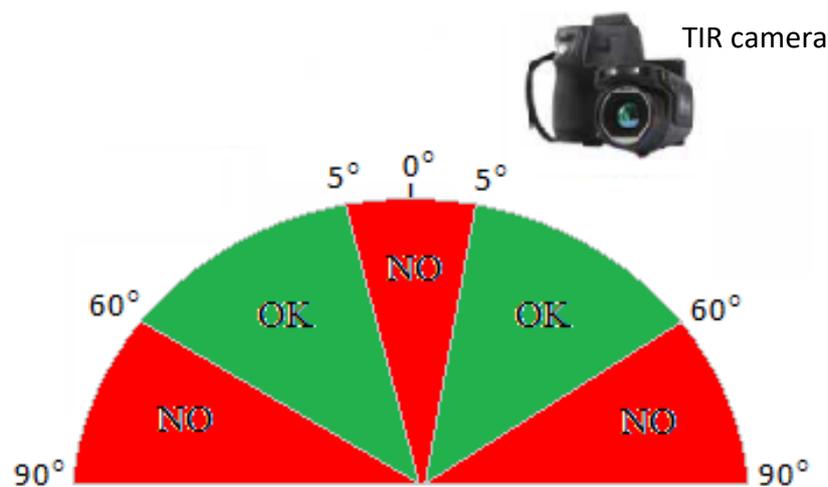
Figure 2.16: Recommended positioning of a TIR camera on capturing thermal images of PV modules (adapted from [100]).

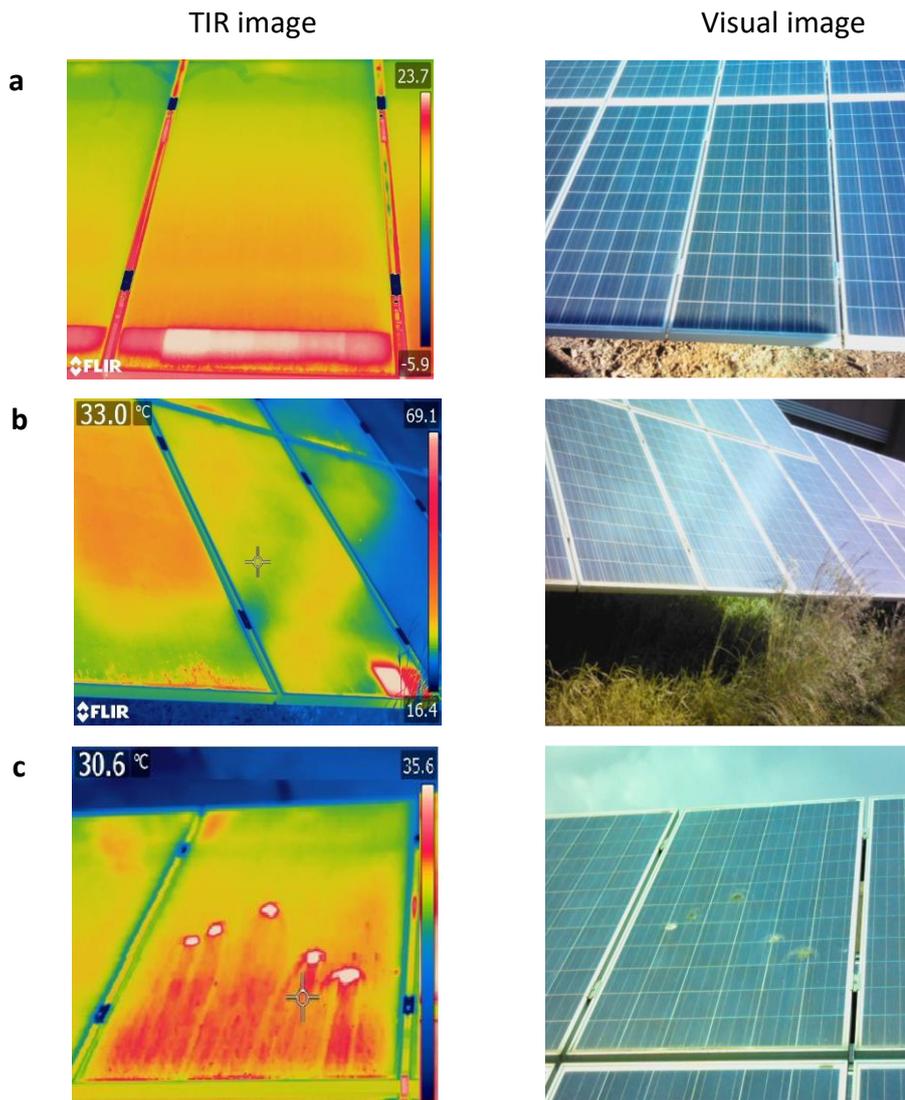
Figure 2.17: TIR and visual images of polycrystalline PV modules having non-uniform temperature distribution due to partial shading caused by (a) neighbouring modules, (b) grass and (c) bird droppings.

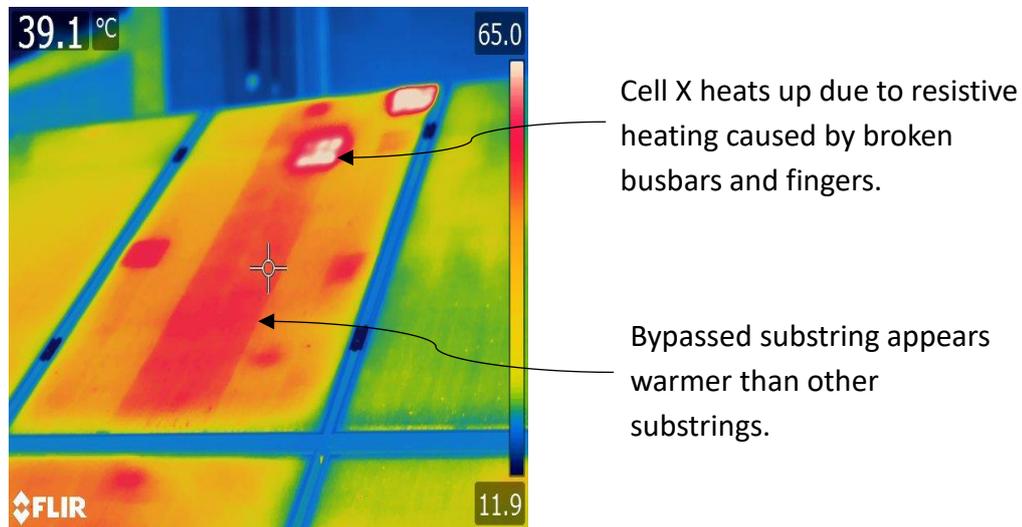
Figure 2.18: TIR image of a crystalline PV module with abnormally hot cell and substring.

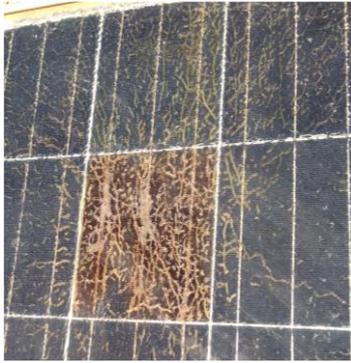
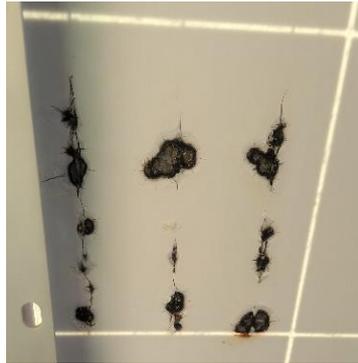
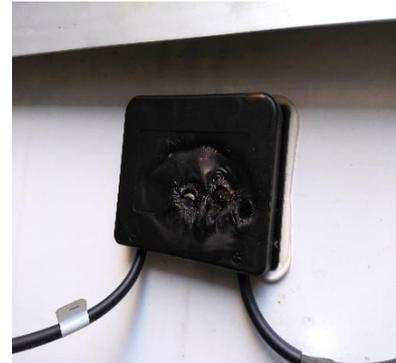
Module glass cracks and cell discolouration

back sheet damage

defective junction box

Figure 2.19: Visual images showing burnt marks due to excessive heating.

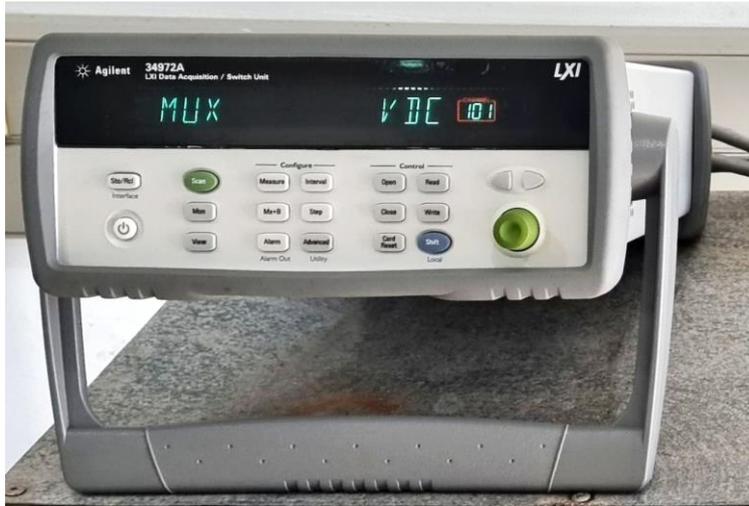
Figure 3.1: Agilent 3472A data logger.

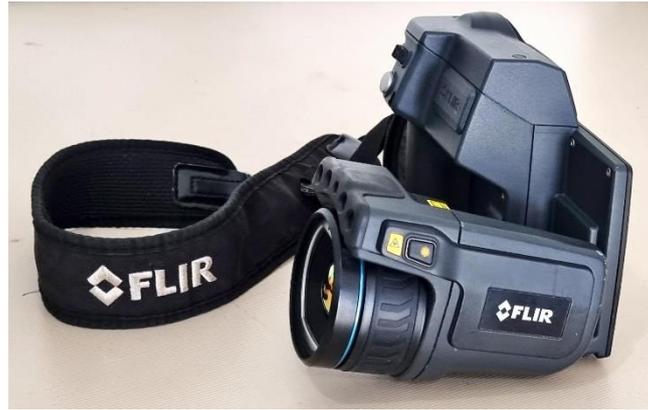
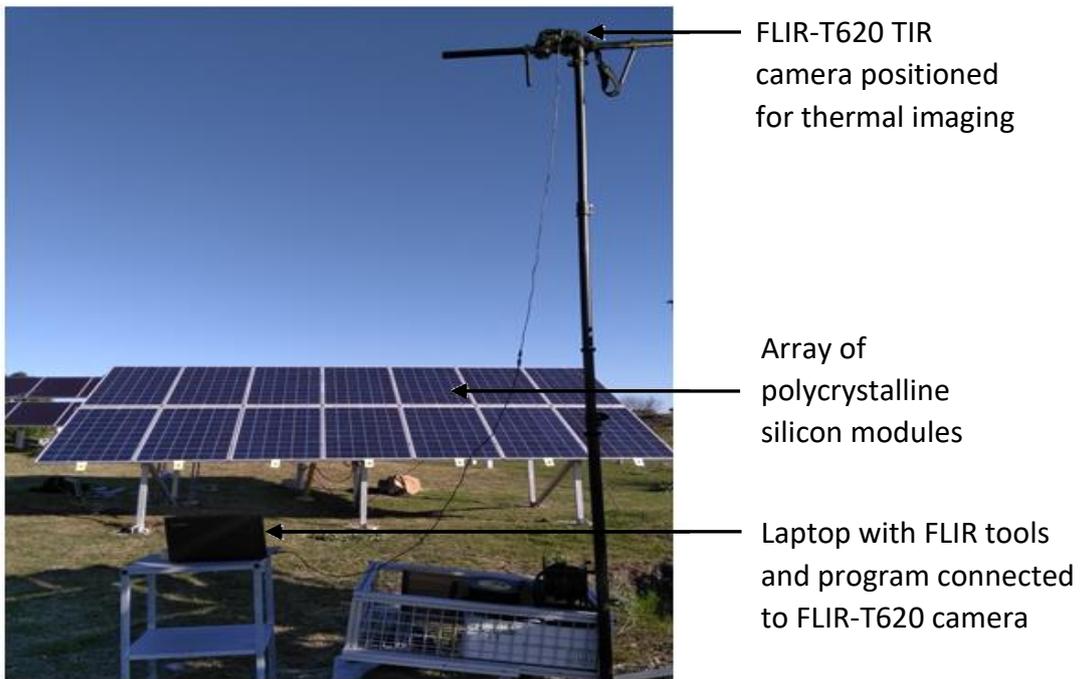
Figure 3.2: (a) FLIR-T620 TIR camera used for taking TIR images. (b) Thermal imaging equipment set up for PV module inspection at the Outdoor Research Facility at Nelson Mandela University.

The TIR camera (FLIR-T620) is a professional thermal imager that has Multi-Spectral Dynamic (MSX) imaging capabilities with high resolution and sensitivity for accurate temperature measurements [107]. The typical test conditions, such as angle of capture, calm environmental conditions, and emissivity settings, on the TIR camera, as highlighted in Section 2.6.6.1 were followed when TIR imaging was carried out on modules. Figure 3.2 shows (a) the FLIR-T620 TIR camera and (b) when the camera is mounted in position for imaging PV modules at the ORF.

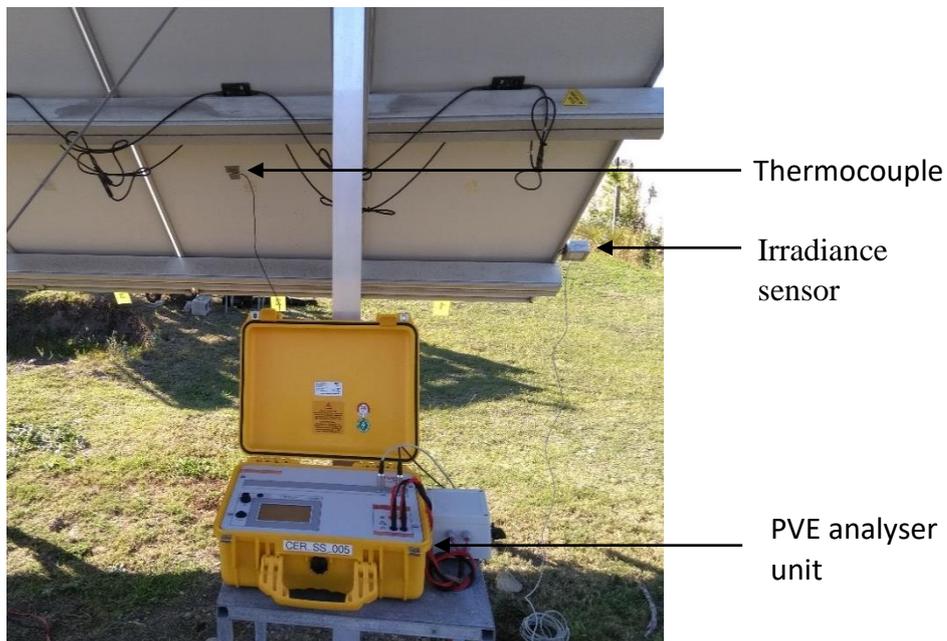
Figure 3.3: I-V curve tracer, PVE PVPM1000X, set up at ORF.

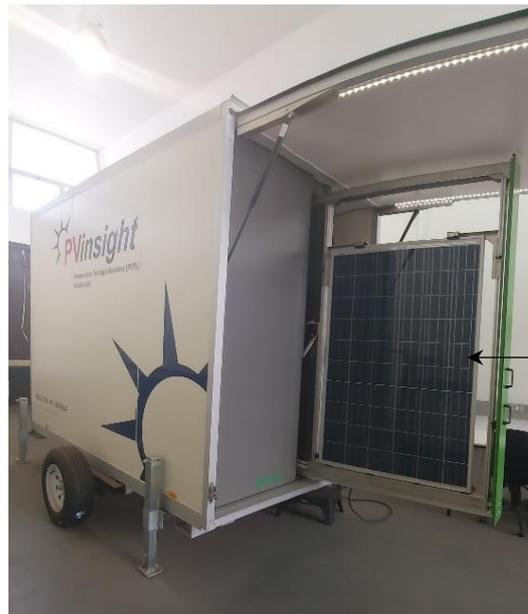
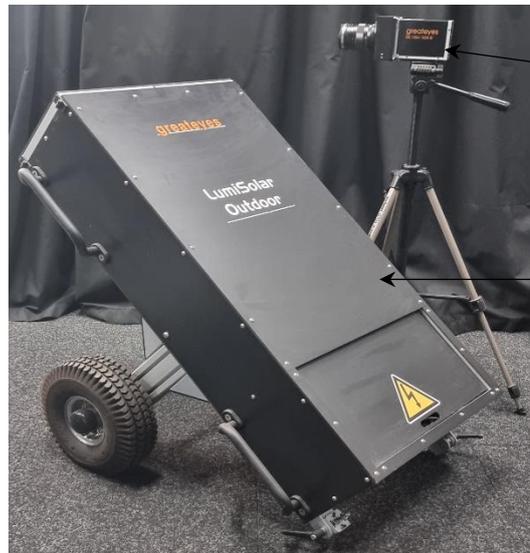
A PV module on a sliding door of the MBJ mobile Lab

EL Camera

Power unit

EL imaging for single modules was carried out using a third-generation Mobile Testing Laboratory, MBJ mobile-Lab 3.0, which uses a high-resolution electroluminescence test system to check for defects in solar cells. String EL images were recorded on-site, during the night using a Greateyes LumiSolar Outdoor EL system. Figure 3.4 shows (a) MBJ mobile-Lab 3.0 and (b) the Greateyes LumiSolar camera (GE 1024 1024 BI) which uses the Charge Coupled Device (CCD) sensors were used for EL measurements following the guidelines described in Section 2.6.5.

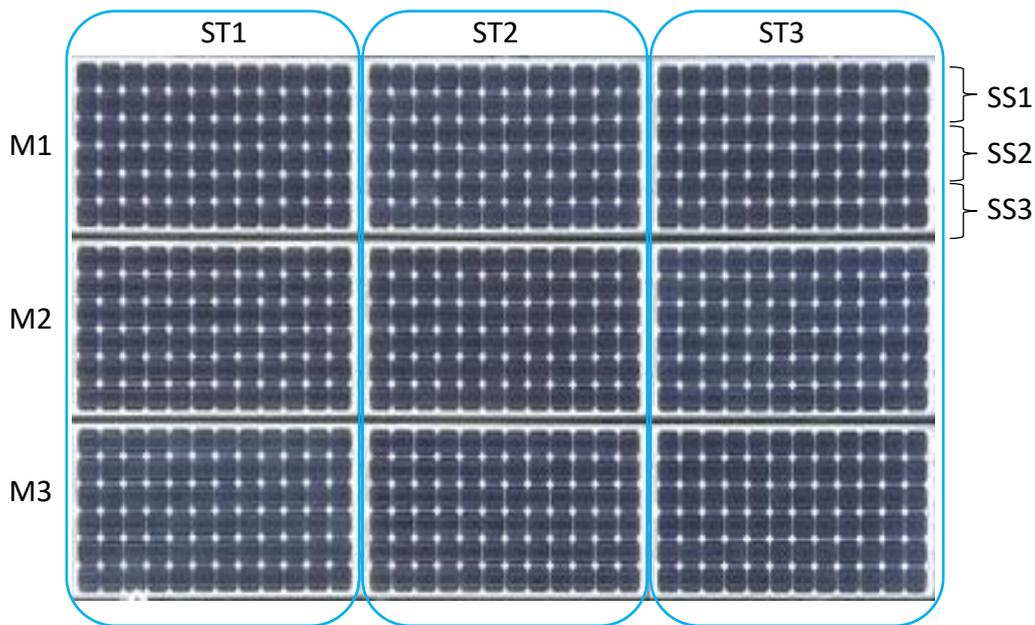
Figure 3.5: Visual image of the monocrystalline silicon PV array at the Outdoor Research Facility (ORF).

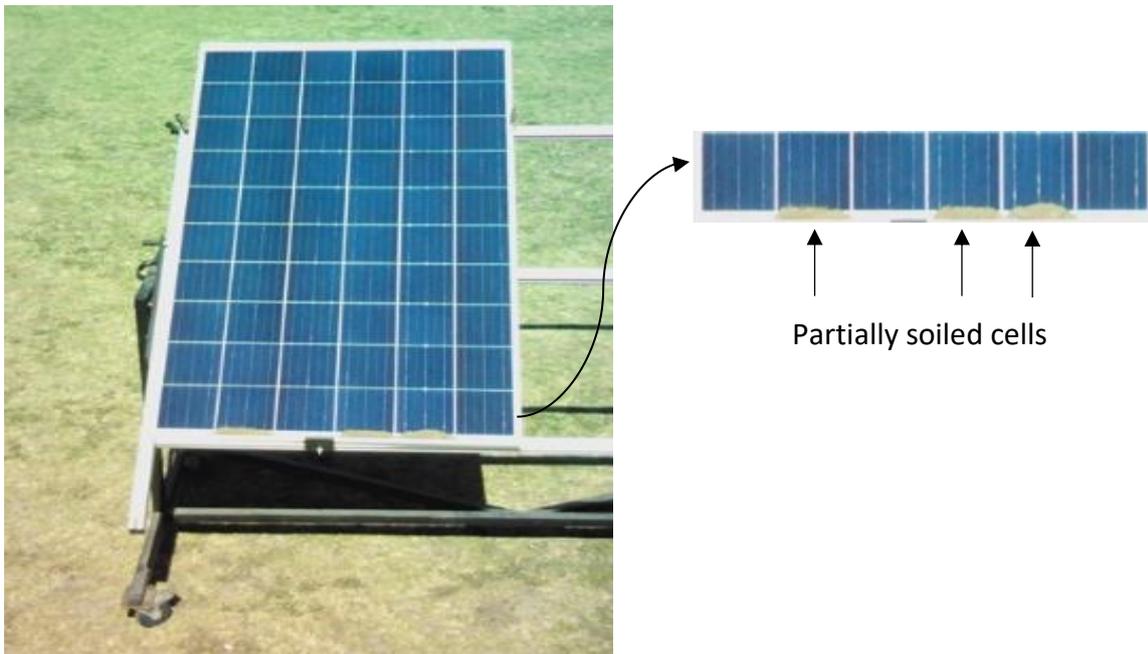
Figure 3.6: Soiled polycrystalline silicon PV module inclined for TIR and I-V curve measurements.

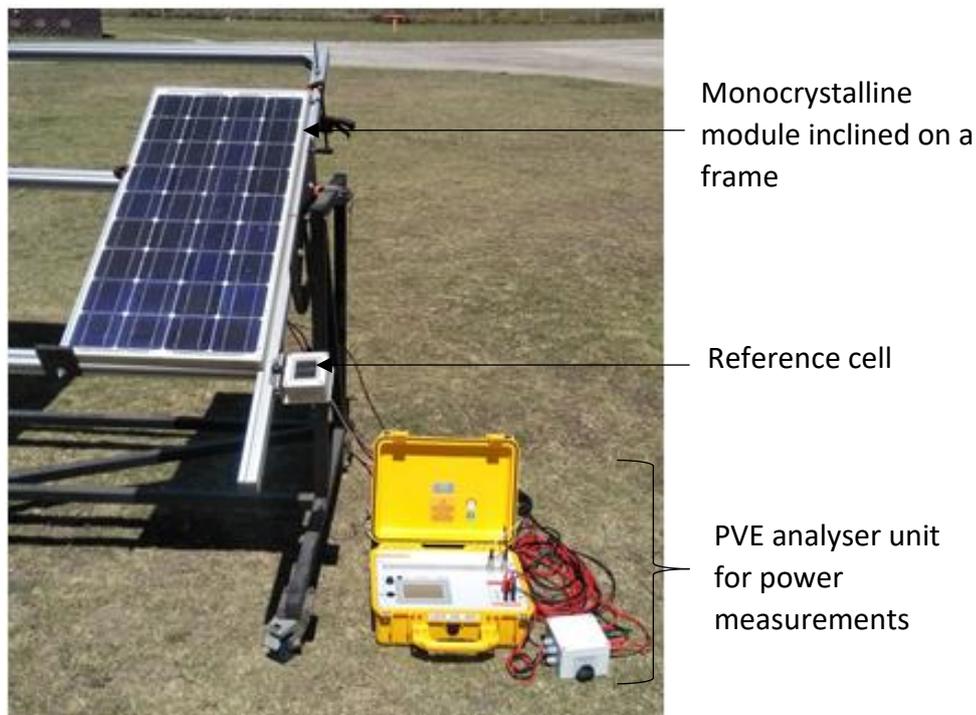
Figure 3.7: Monocrystalline silicon PV module set up for power and TIR measurements on varying load.

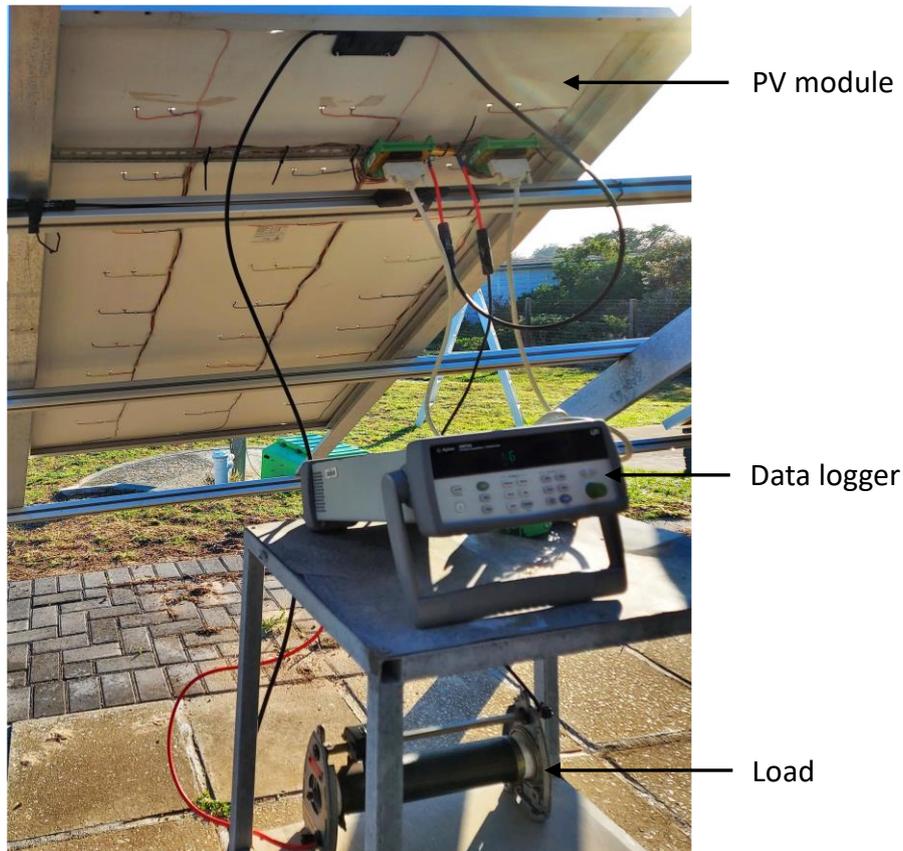
Figure 3.8: Experimental set-up for monitoring I-V and Thermal characteristics of individual cells in a polycrystalline PV module.

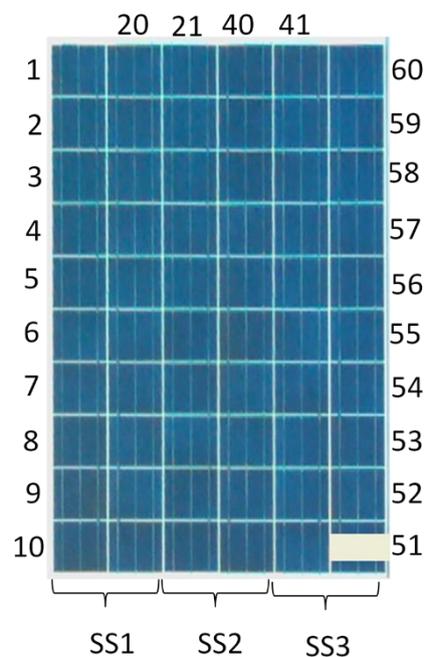
Figure 3.9: Visual image of a polycrystalline PV module with cells numbered from top left to top right and having 60% shading applied on cell 51.

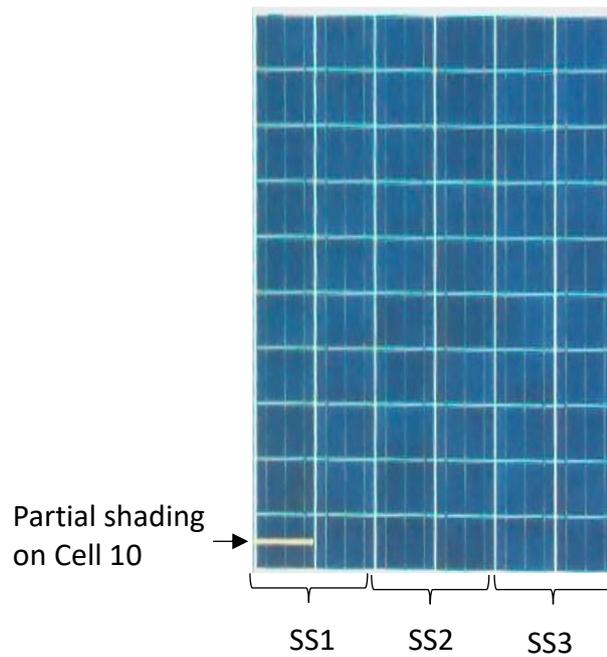
Figure 3.10: Polycrystalline silicon PV module with partial shading (~5%) on cell 10.

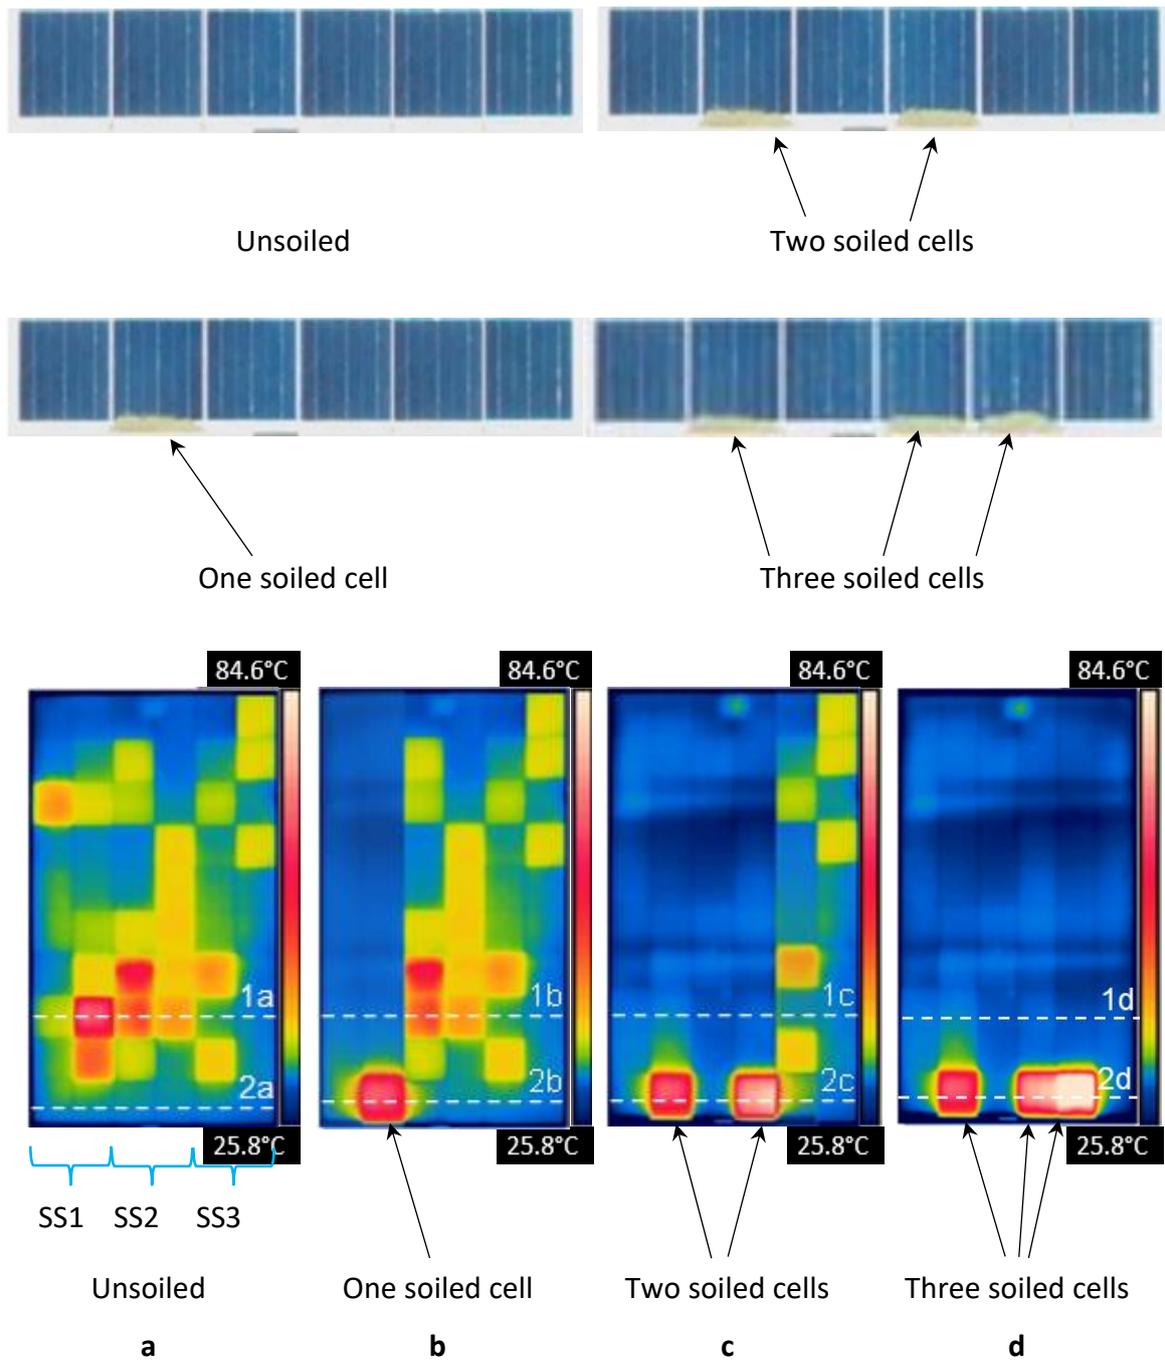
Figure 4.1: Thermal images of the p-Si PV module captured in a short-circuit condition with different soiling conditions with the module having (a) unsoiled cells, (b) one soiled cell, (c) two soiled cells, (d) three soiled cells. ROIs, 1a - d and 2a - d, are shown on the TIR images for temperature line profile analysis. The enlarged visual images show the soiling conditions on the cells.

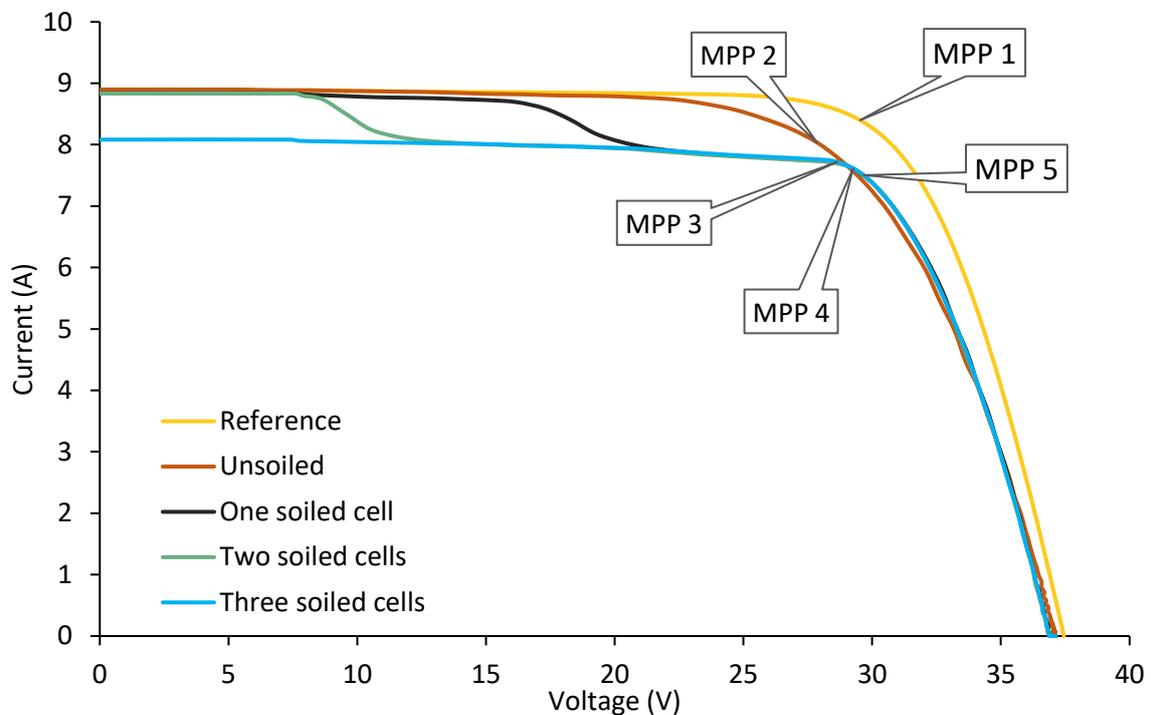
Figure 4.3: I-V characteristics of the polycrystalline silicon module under different soiling conditions. The reference I-V curve created in PVSIM is shown.

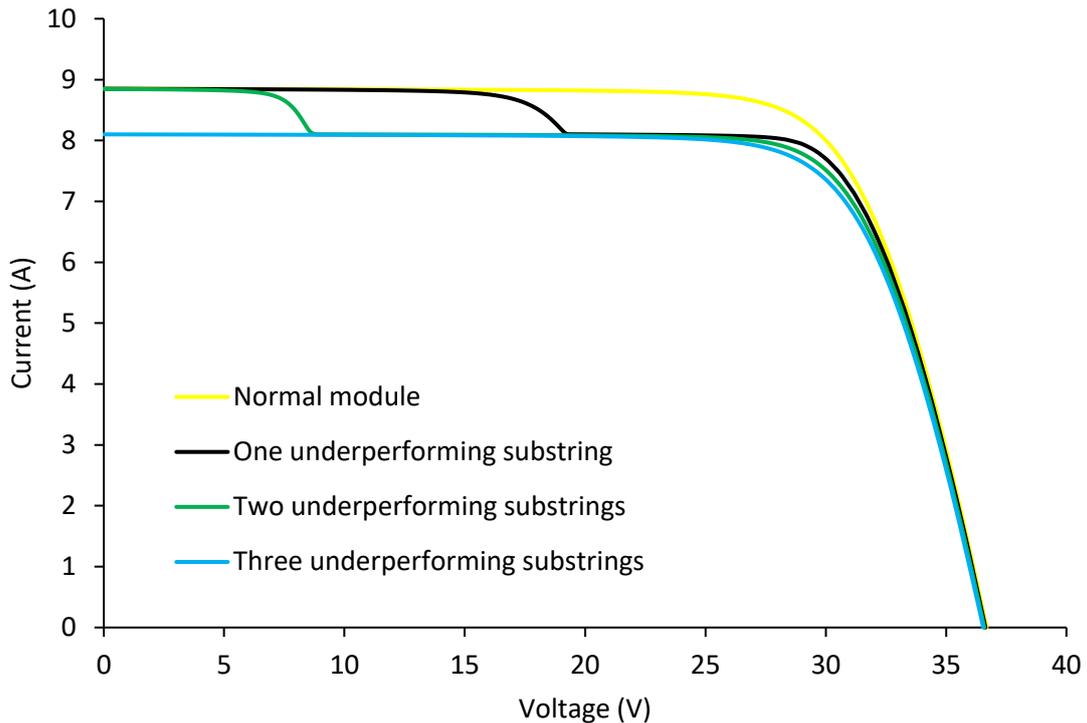
Figure 4.4: I-V curves modelled in PVSIM and simulating different soiling scenarios on the polycrystalline module.

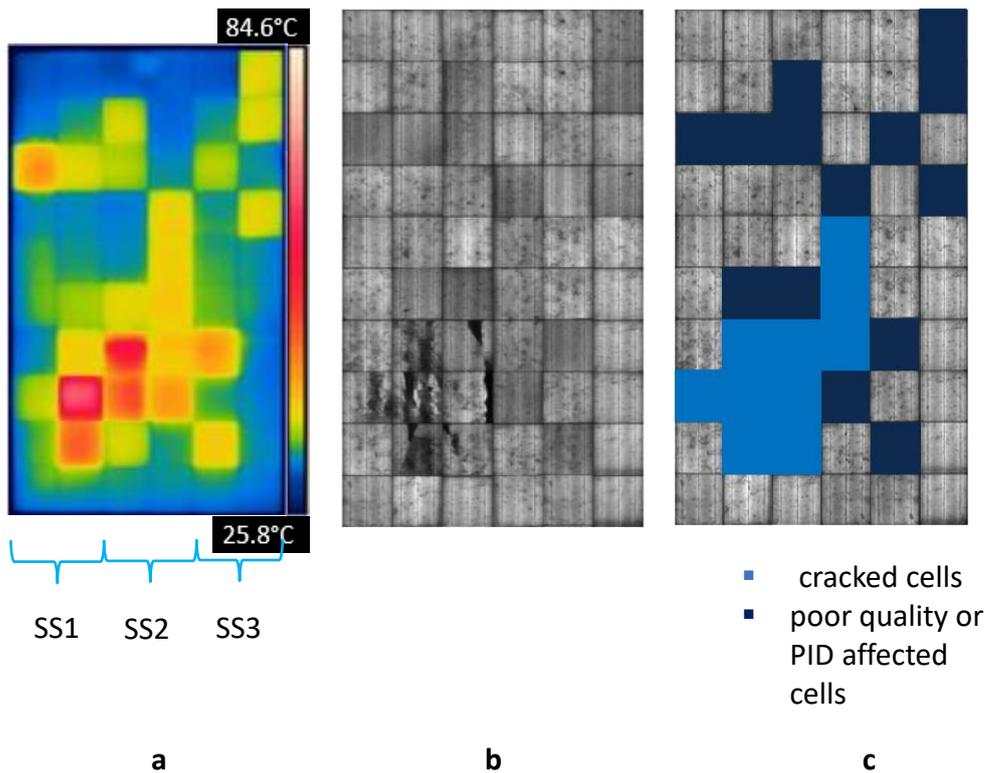
Figure 4.5: (a) TIR and (b) EL images of the polycrystalline silicon PV module. (c) EL image of the module with classified cell anomalies.
