**Investigation of Thermal and Electrical
characteristics of crystalline silicon
Photovoltaic modules under varying
operational conditions**

Monphias Vumbugwa

Doctor of Philosophy (Physics)

to be awarded at the Nelson Mandela University

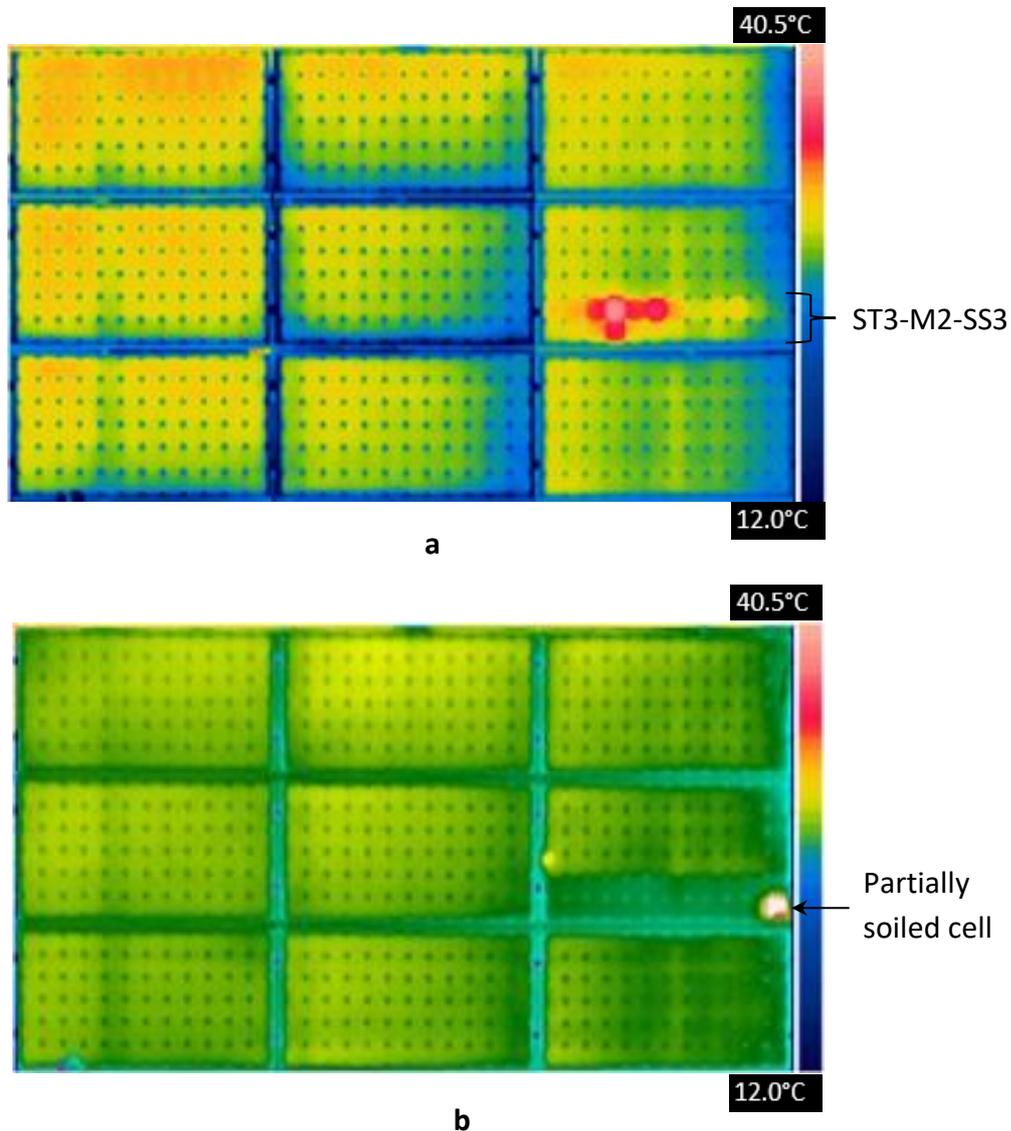
Figure 4.6: Thermal images of the 1.6 kW array under 1 sun and output power of 1100 W, (a) unsoiled and (b) with a partially soiled cell.

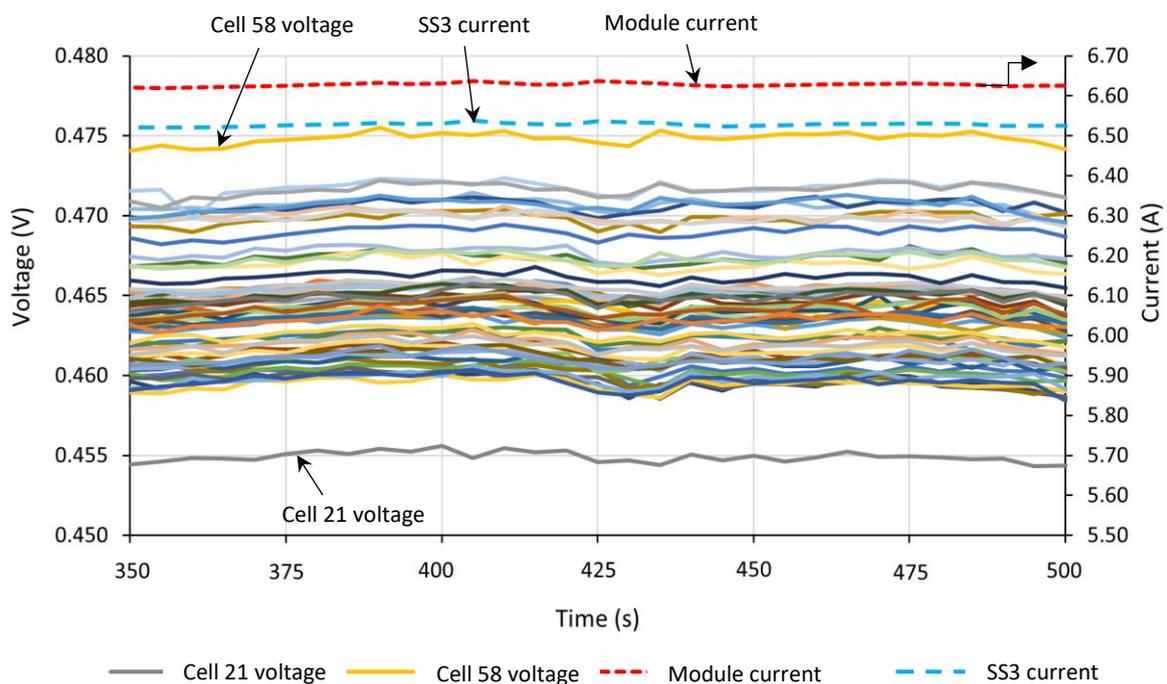
Figure 4.7: Mismatch in cell voltages recorded under steady conditions. The solid lines show the voltages of the cells. The red and blue broken lines represent currents produced by the module and substring 3 (SS3), respectively.

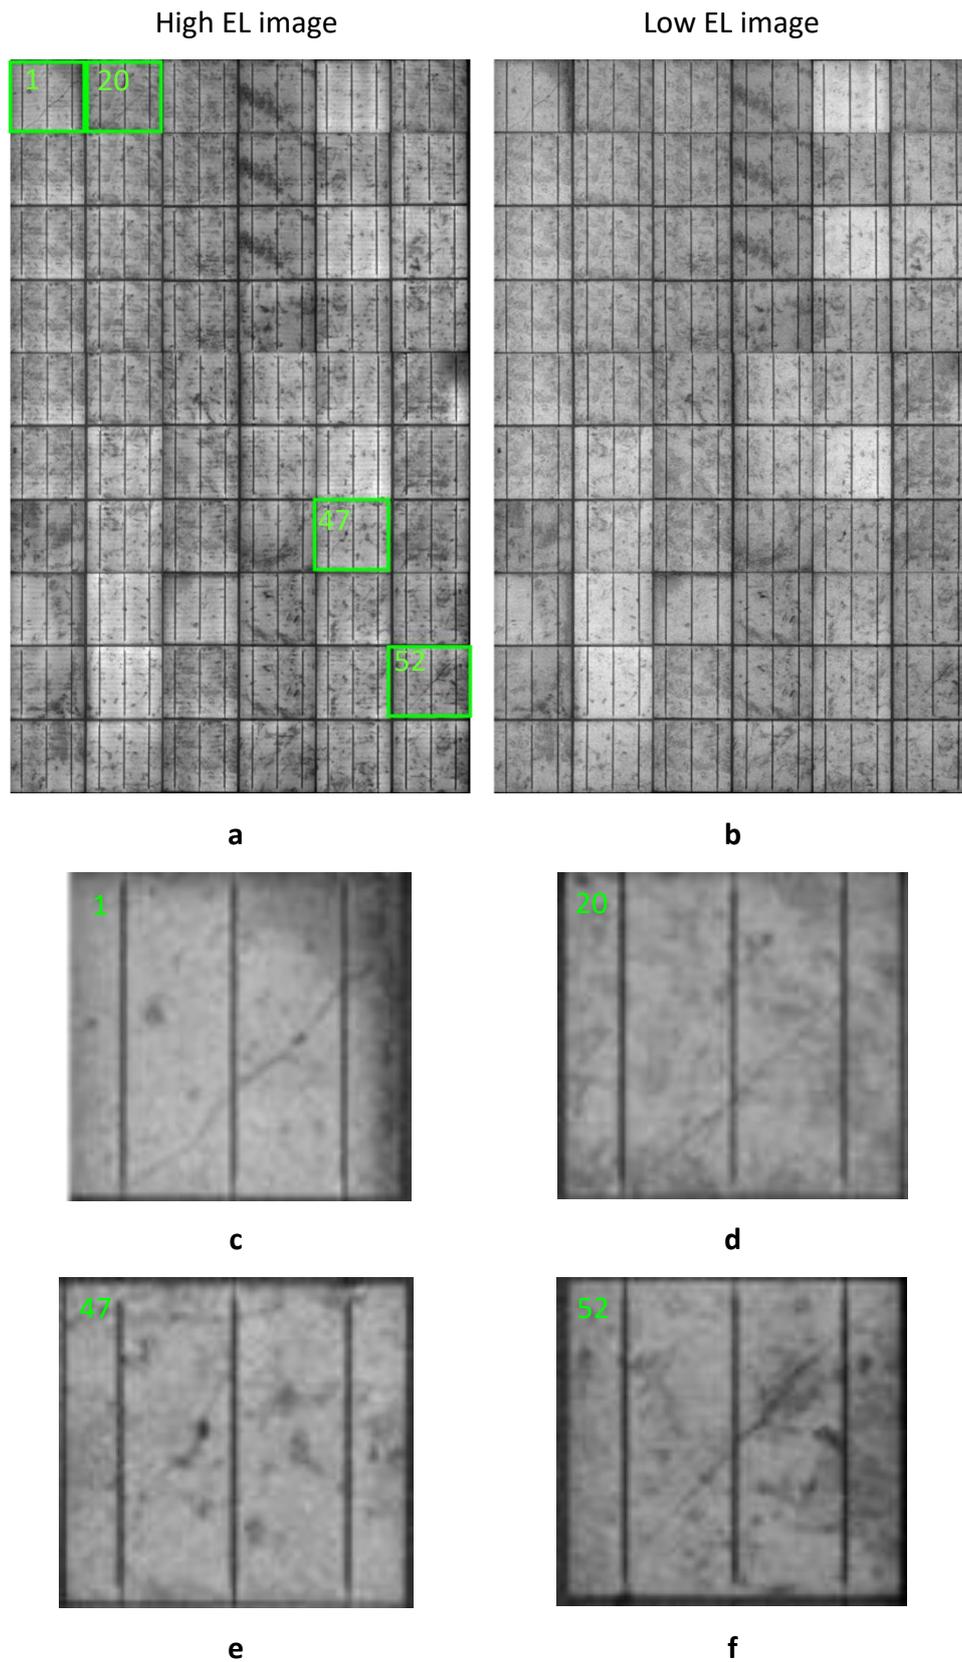
Figure 4.8: (a) High and (b) low current EL images of the multi-crystalline silicon photovoltaic module recorded at (a) 110% and (b) 10% of the I_{sc} . Cells 1, 20, 47 and 52 are enlarged in (c), (d), (e) and (f) respectively.

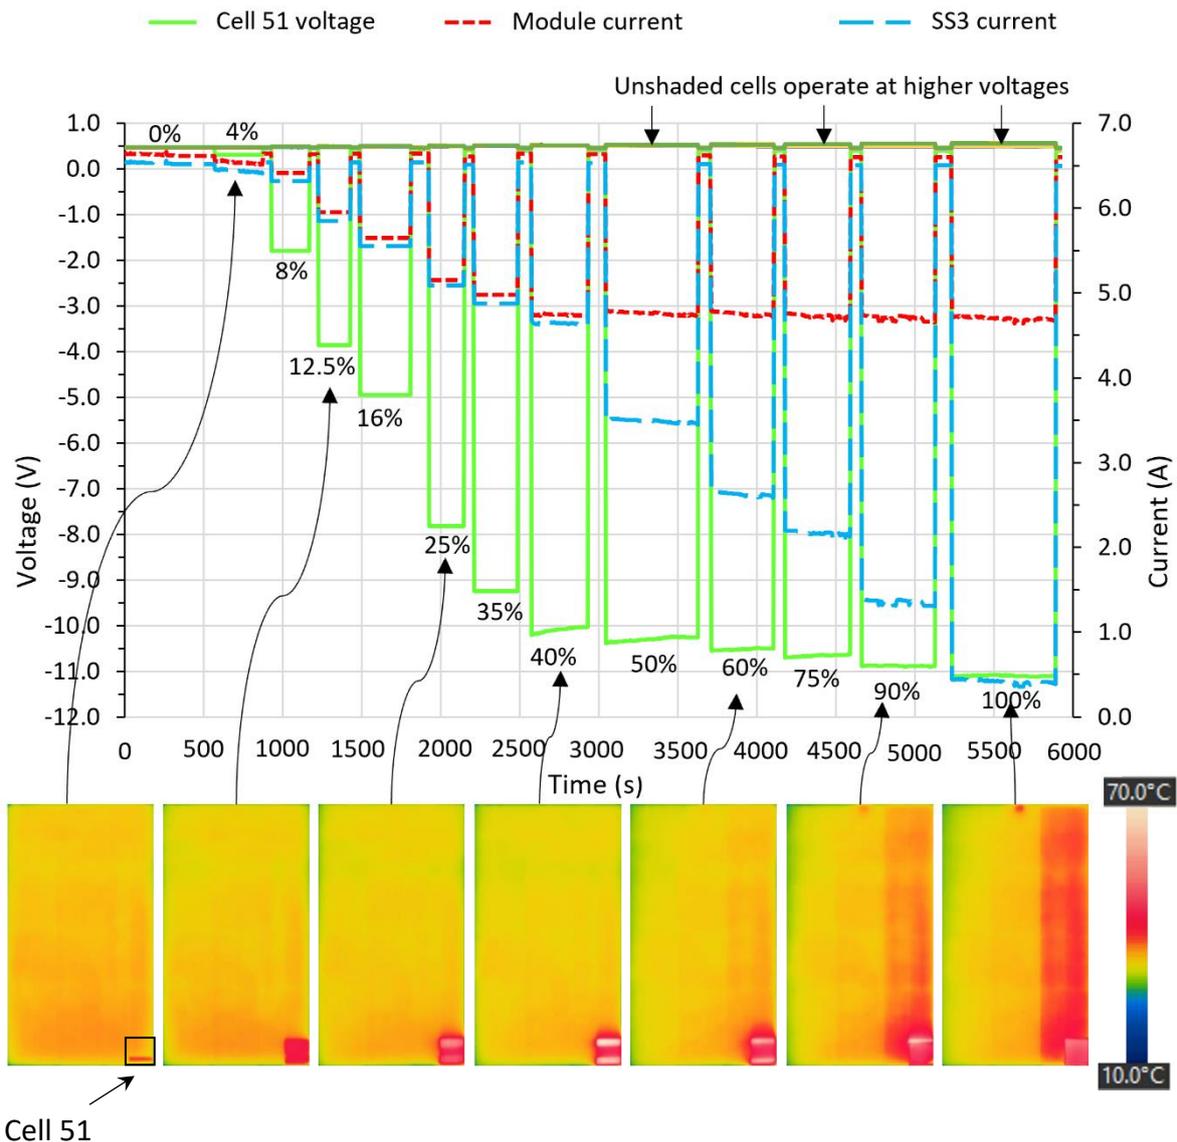
Figure 4.9: Module and substring, SS3, currents and cell voltage measurements together with TIR images taken when cell 51 was under different shading levels, of cardboard covering a portion of the cell. The voltages of the unshaded cells are indistinguishable from each other and show a small increase when cell 51 is shaded.

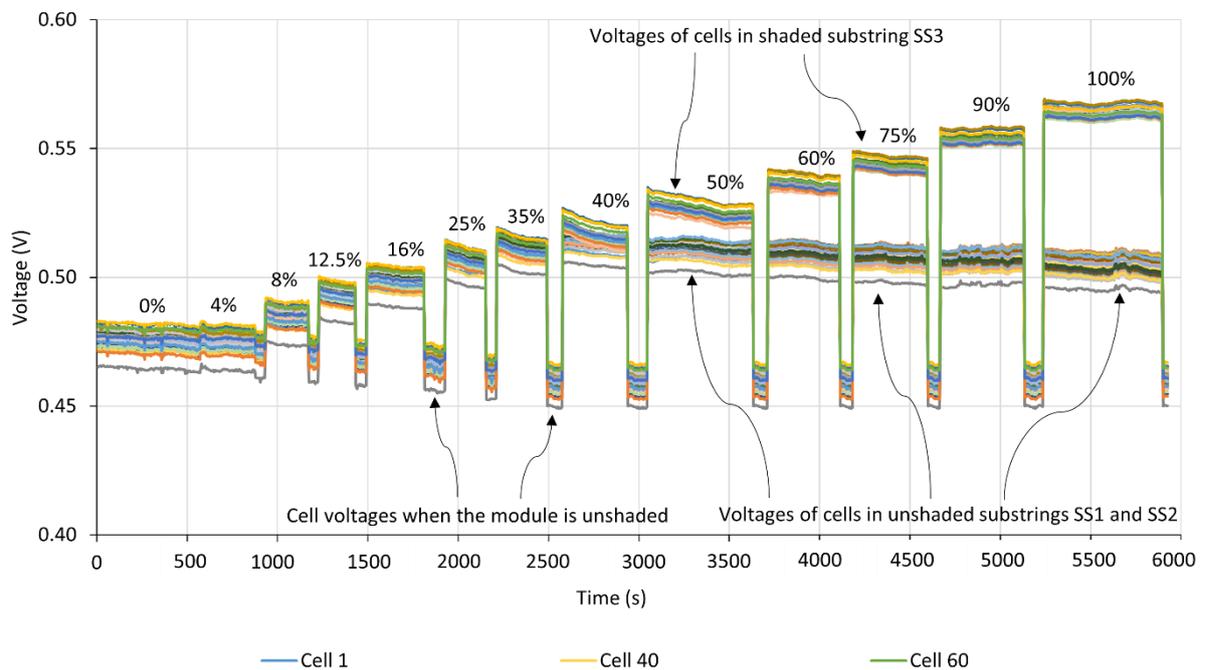
Figure 4.10: Effect of shading on operational voltages of unshaded cells.

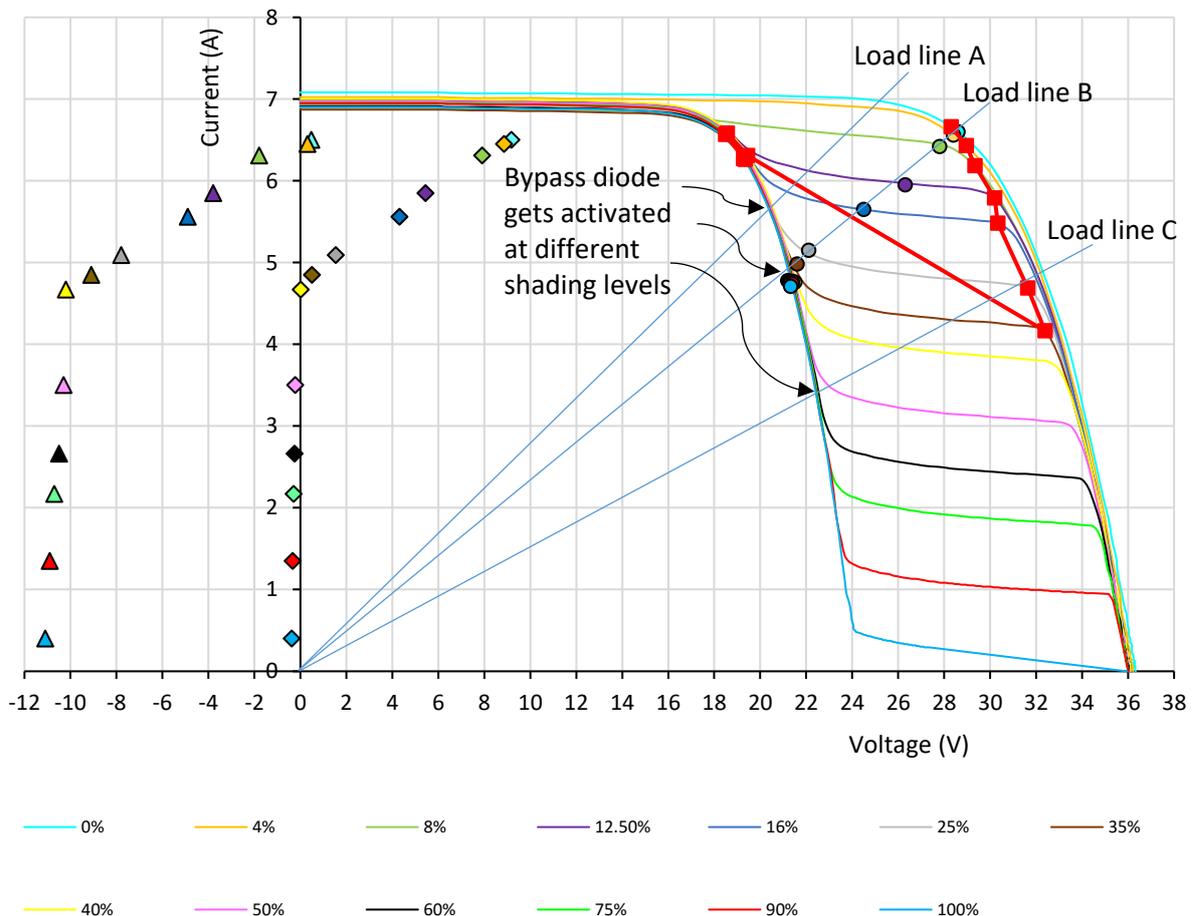
Figure 4.11: Representative I-V curve characteristics of the module when cell 51 was under different shading levels. The operational points of the module (circles), substring SS3 (diamonds), and cell 51 (triangles) are indicated for different shading levels, 0 to 100%.

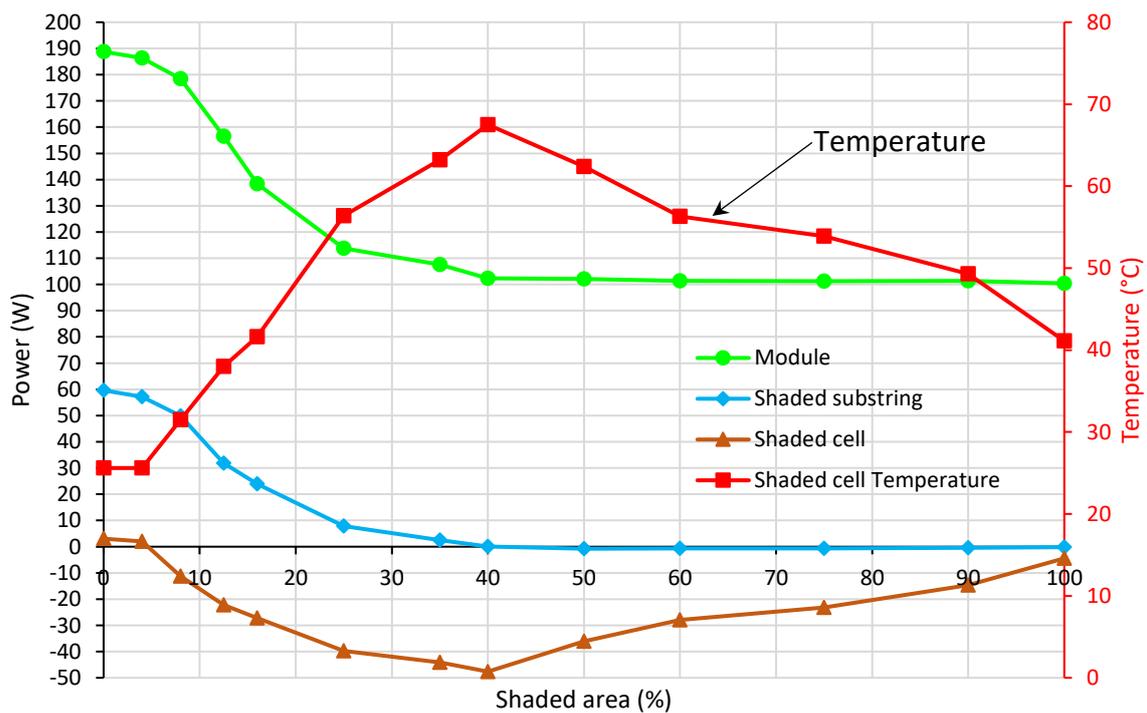
Figure 4.12: Power and operational temperature trends under different shading levels of cell 51.

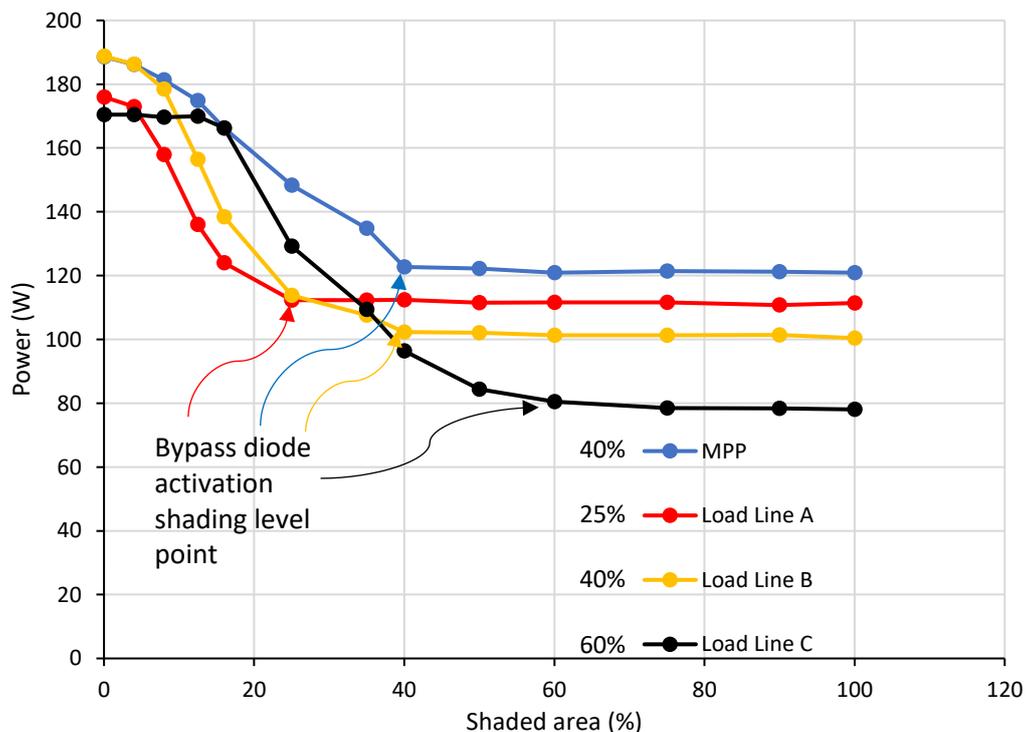
Figure 4.13: Trends of power generated by the module at different load lines.

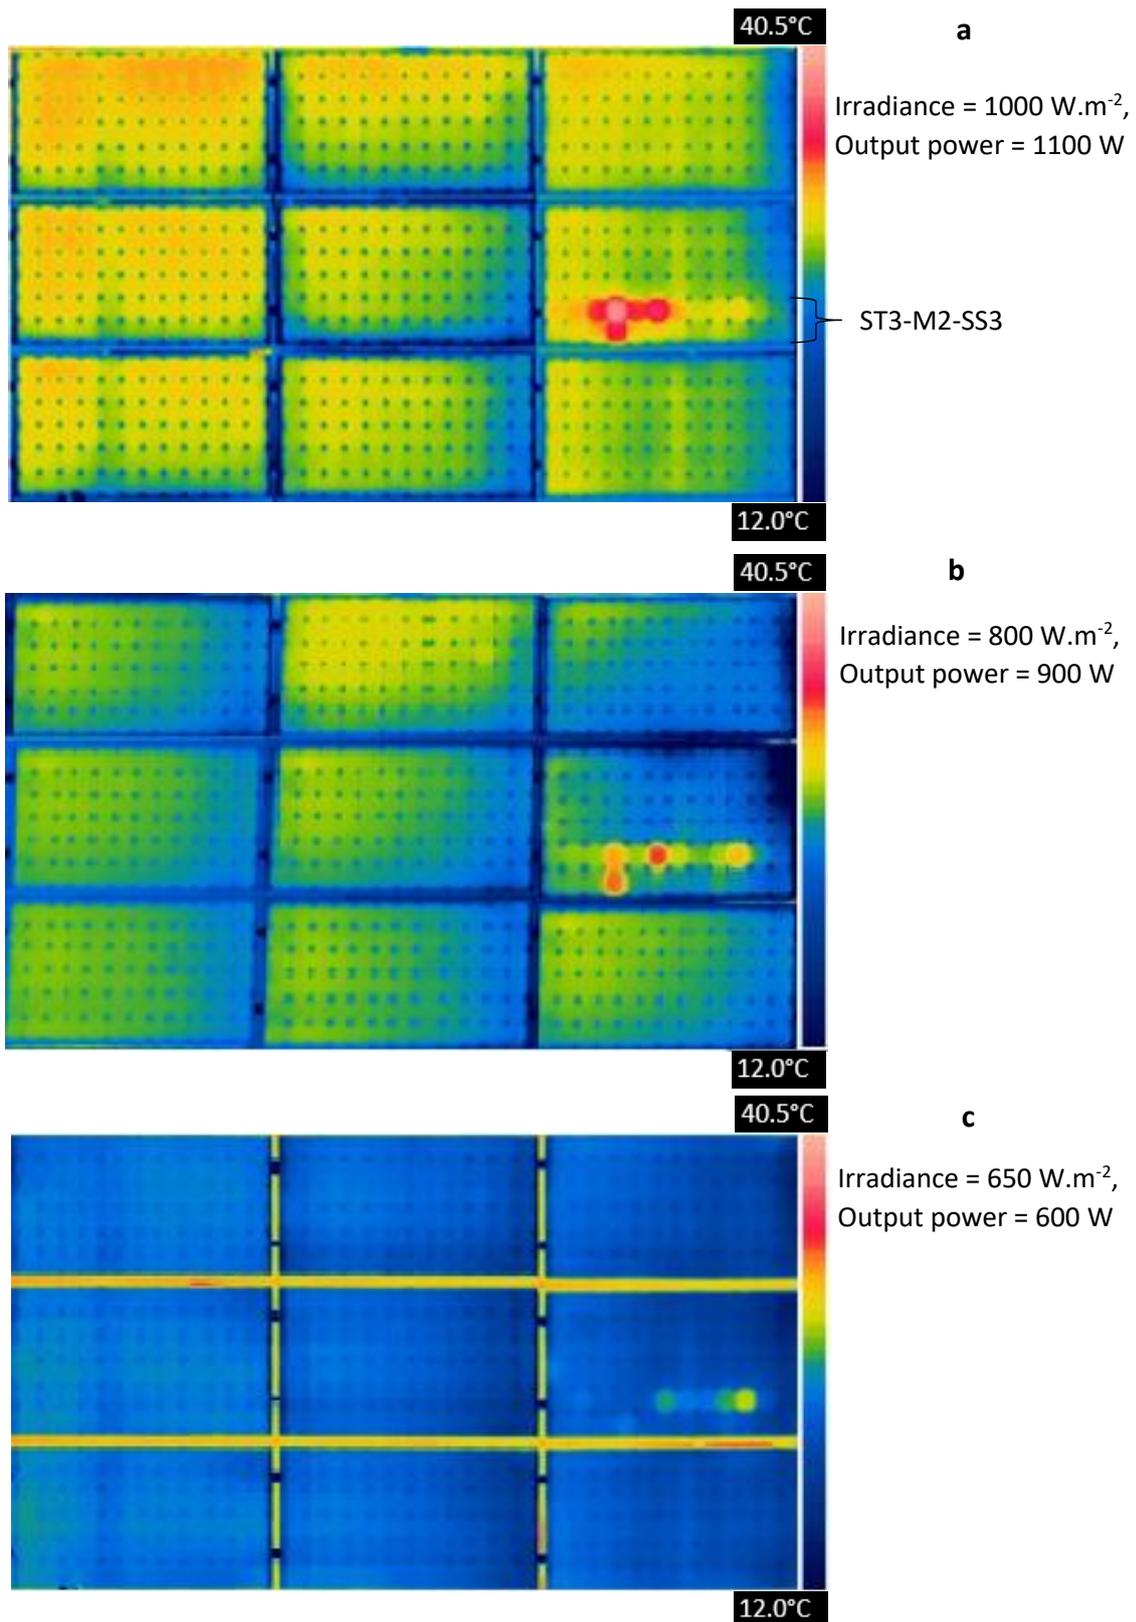
Figure 4.14: TIR images of the 1.6 kW array captured under different irradiance and output power, (a) Irradiance of 1000 W.m^{-2} and output power of 1100 W, (b) Irradiance of 800 W.m^{-2} and output power of 900 W and (c) Irradiance of 650 W.m^{-2} and output power of 600 W.

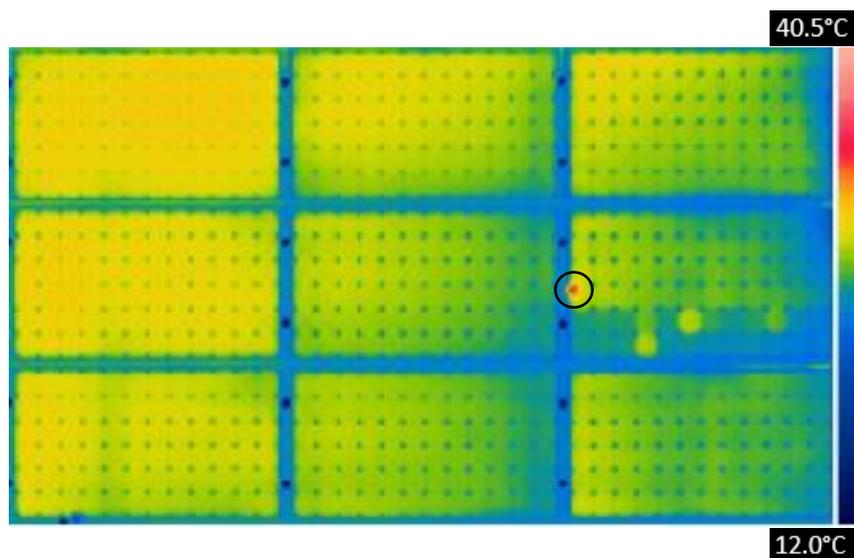
Figure 4.15: Thermal image of the 1.6 kW array when it was in open circuit conditions and receiving 1 sun.

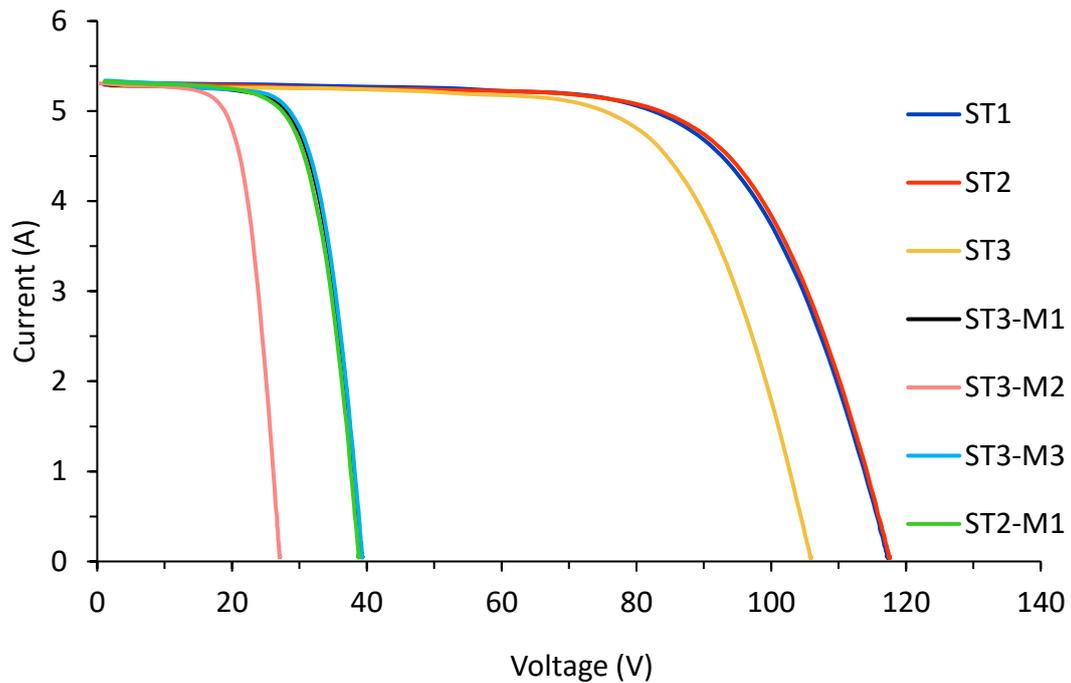
Figure 4.16: I-V curve characteristics of the strings and modules in the 1.6 kW array.

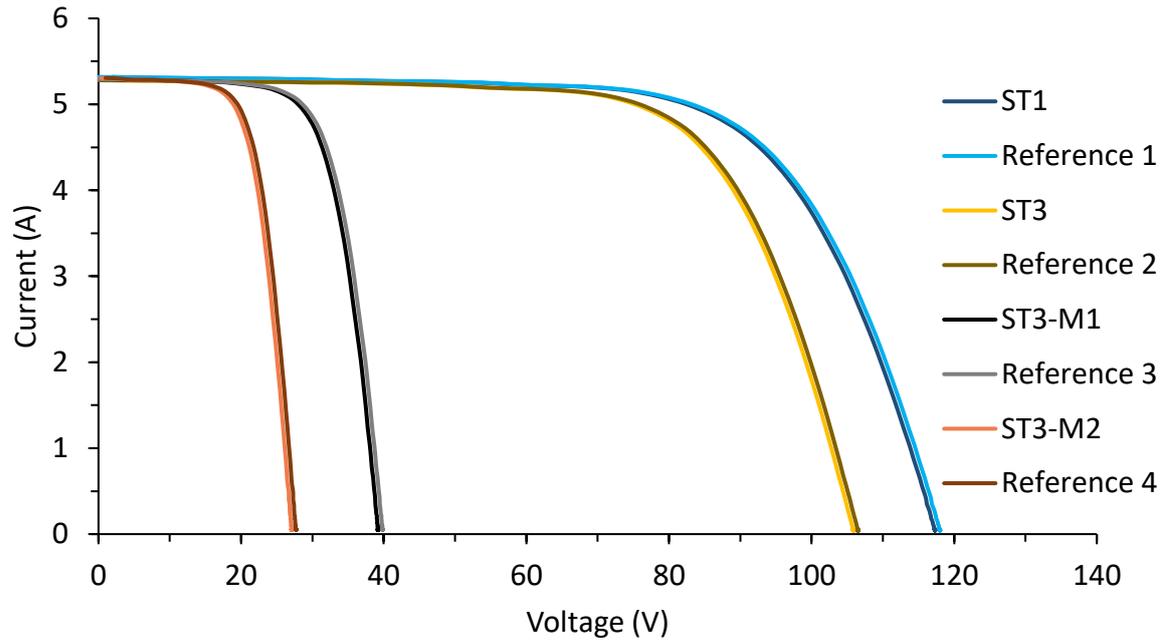
Figure 4.17: I-V curves of strings and modules in the 1.6 kW array compared to references that were simulated in PVSIM.

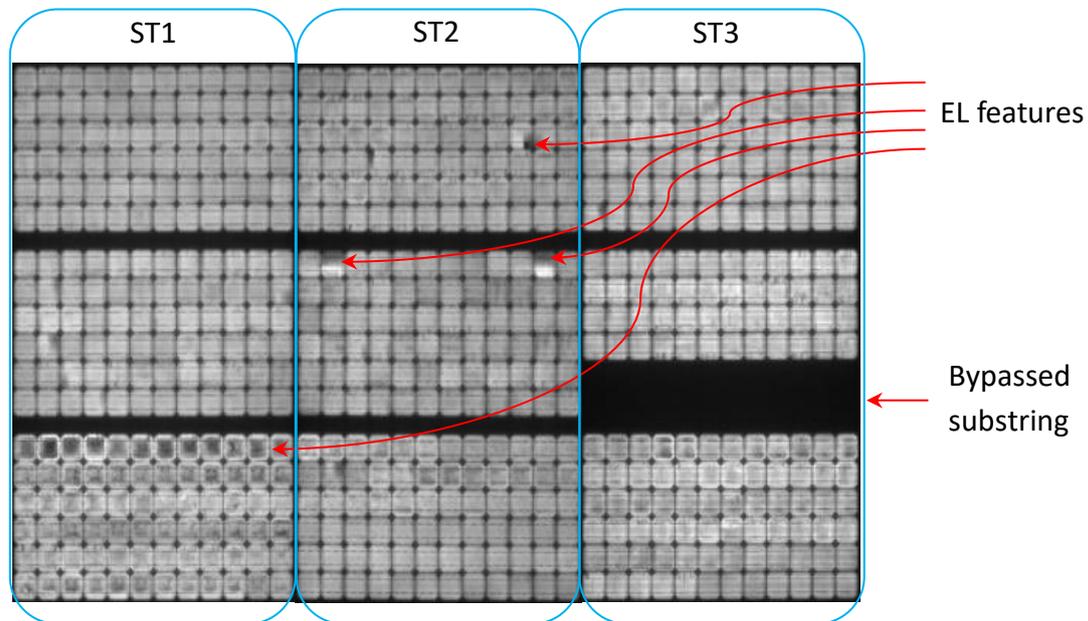
Figure 4.18: EL image of the 1.6 kW array showing a bypassed substring and other EL features.

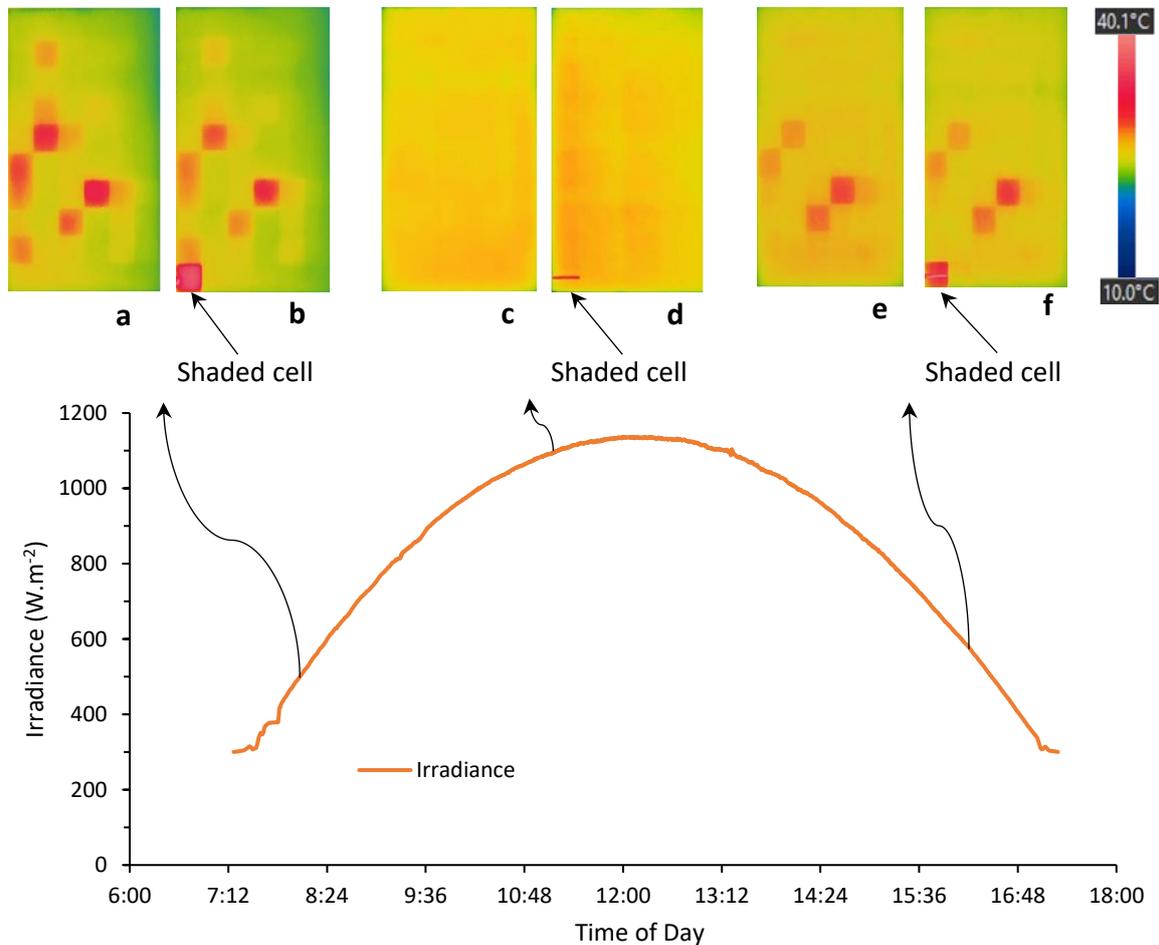
Figure 4.20: TIR images of the polycrystalline PV module captured under varying irradiance, with partial shading on one cell [TIR images (b), (d) and (f)] and with unshaded cells [TIR images (a), (c) and (e)]. The TIR images were recorded under irradiance of 500 W.m^{-2} [(a), (b)], 1100 W.m^{-2} [(c), (d)] and 550 W.m^{-2} [(e), (f)].

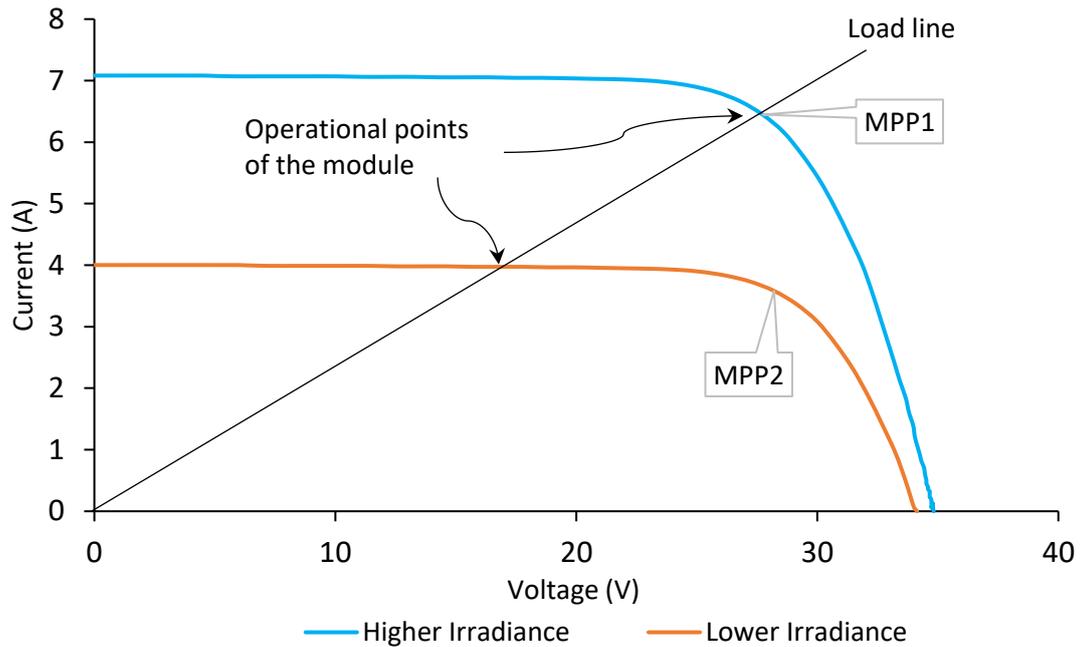
Figure 4.21: I-V curves of a crystalline PV module operating under constant load conditions and different irradiance levels.

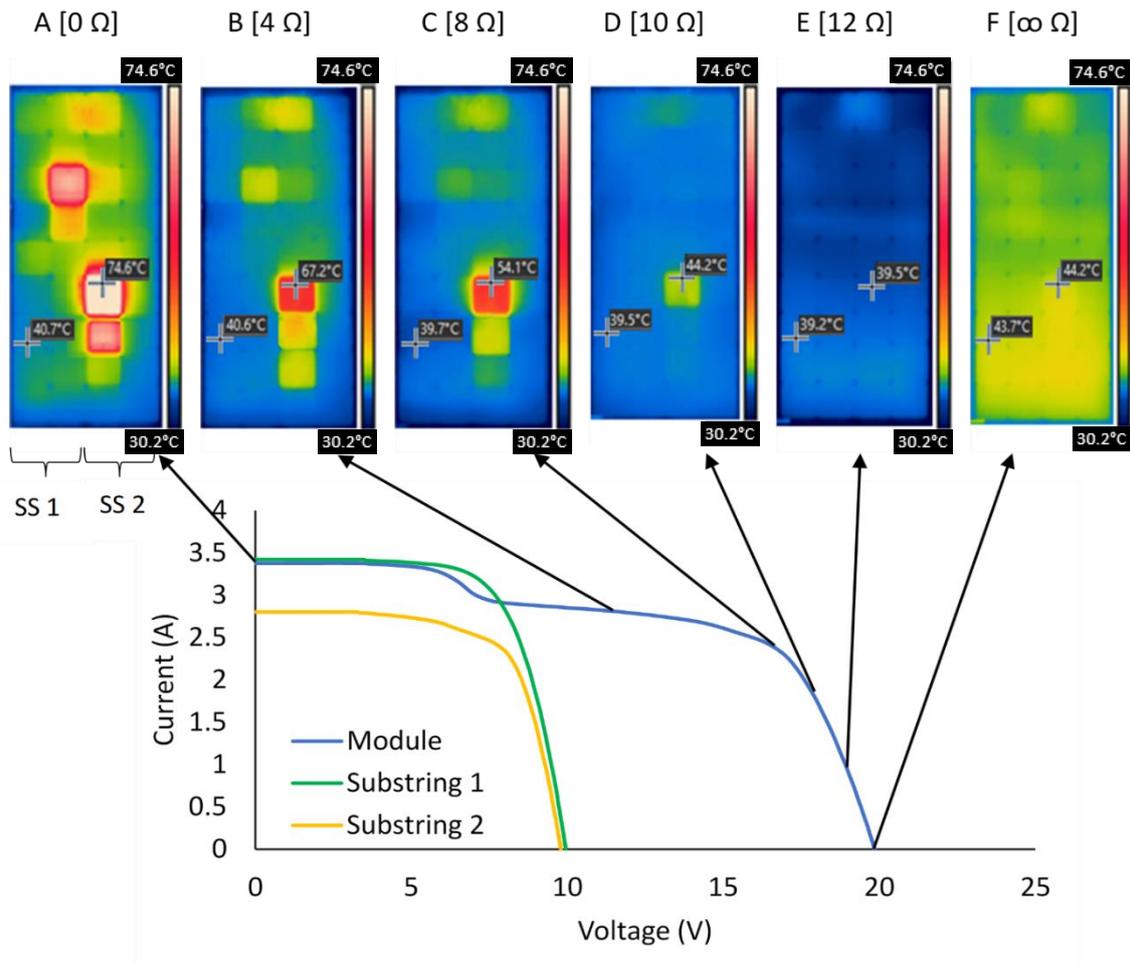
Figure 4.22: Thermal infrared images of the monocrystalline module captured under varying loads and the current-voltage plots of the module and substrings.

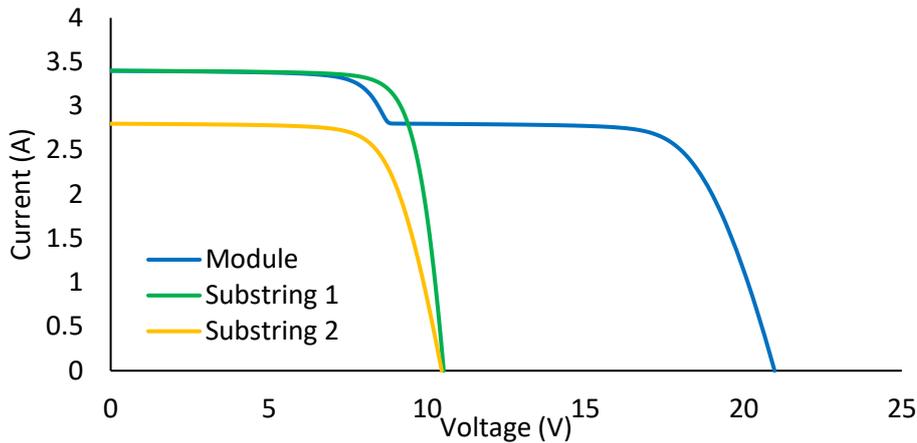
Figure 4.23: I-V curves of the module and substrings, modelled in PVSIm, simulating the operation of the monocrystalline module.

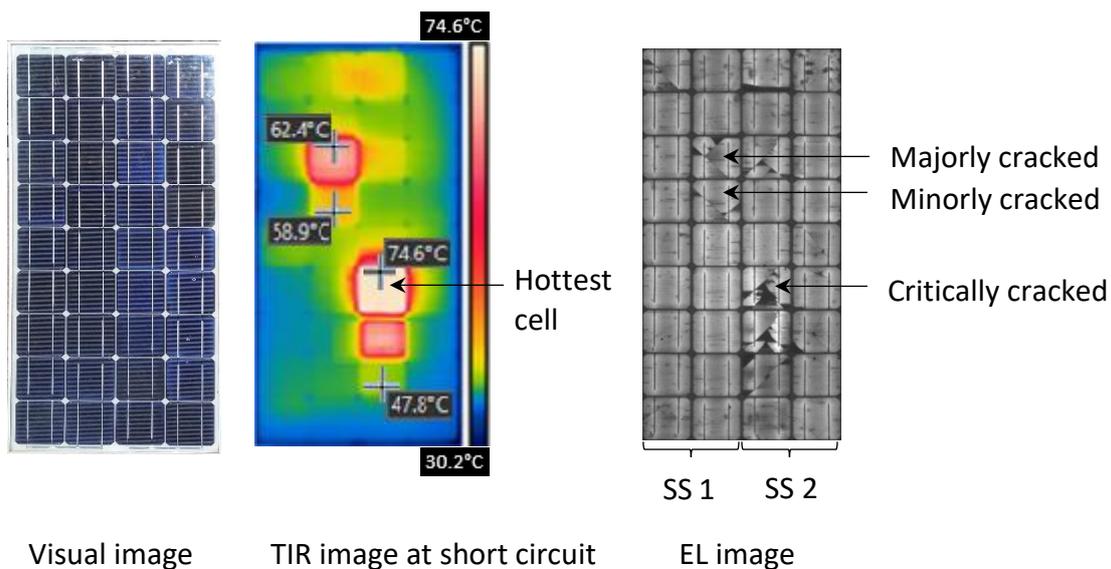
Figure 4.24: Visual, thermal infrared and electroluminescence images of the monocrystalline photovoltaic module. TIR = Thermal Infrared, EL = Electroluminescence, SS = substring

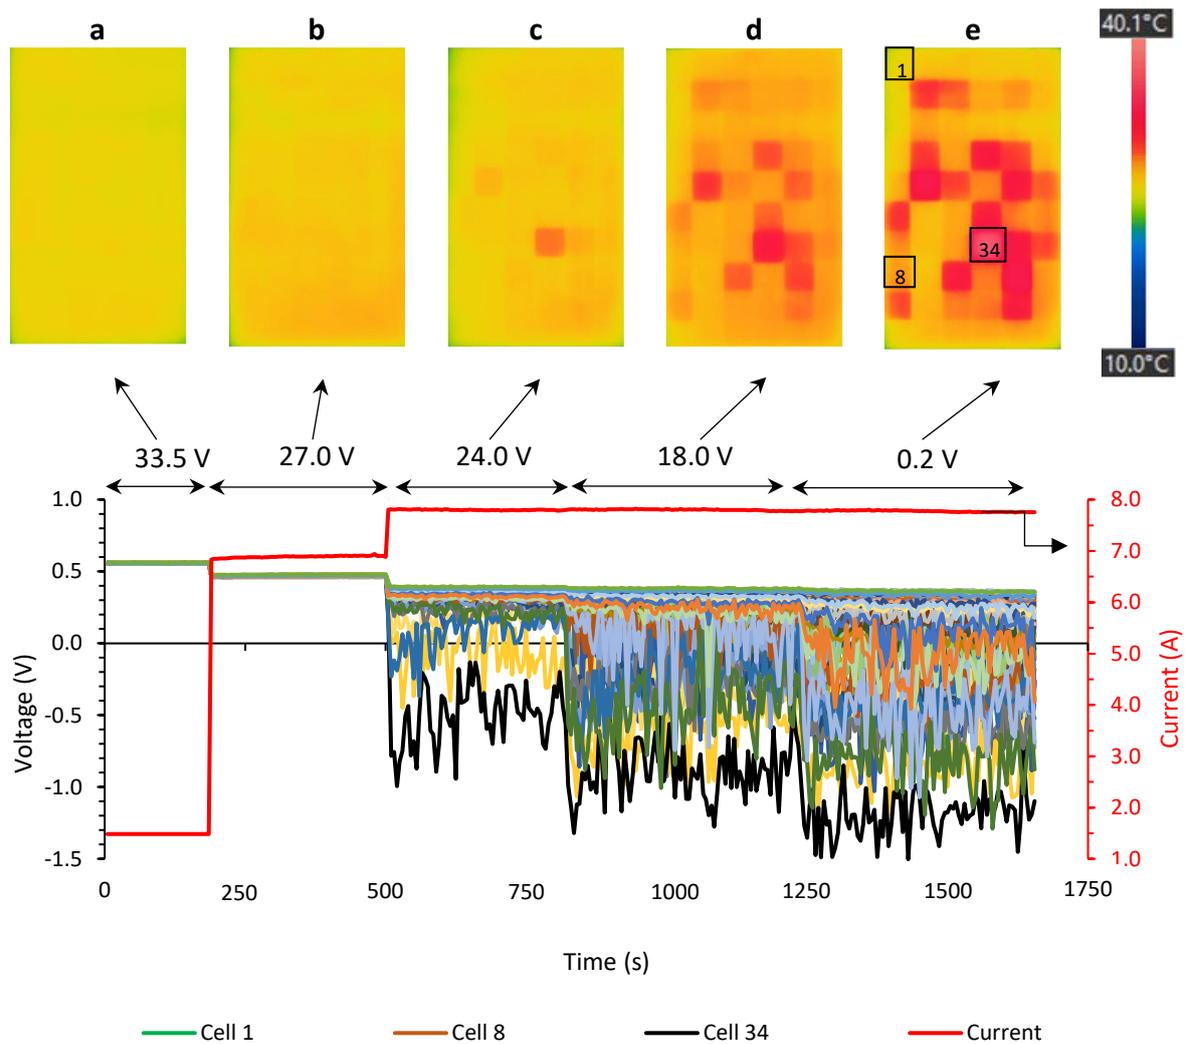
Figure 4.25: Module current, cell voltages and thermal characteristics of a polycrystalline PV module recorded under different operational voltages.

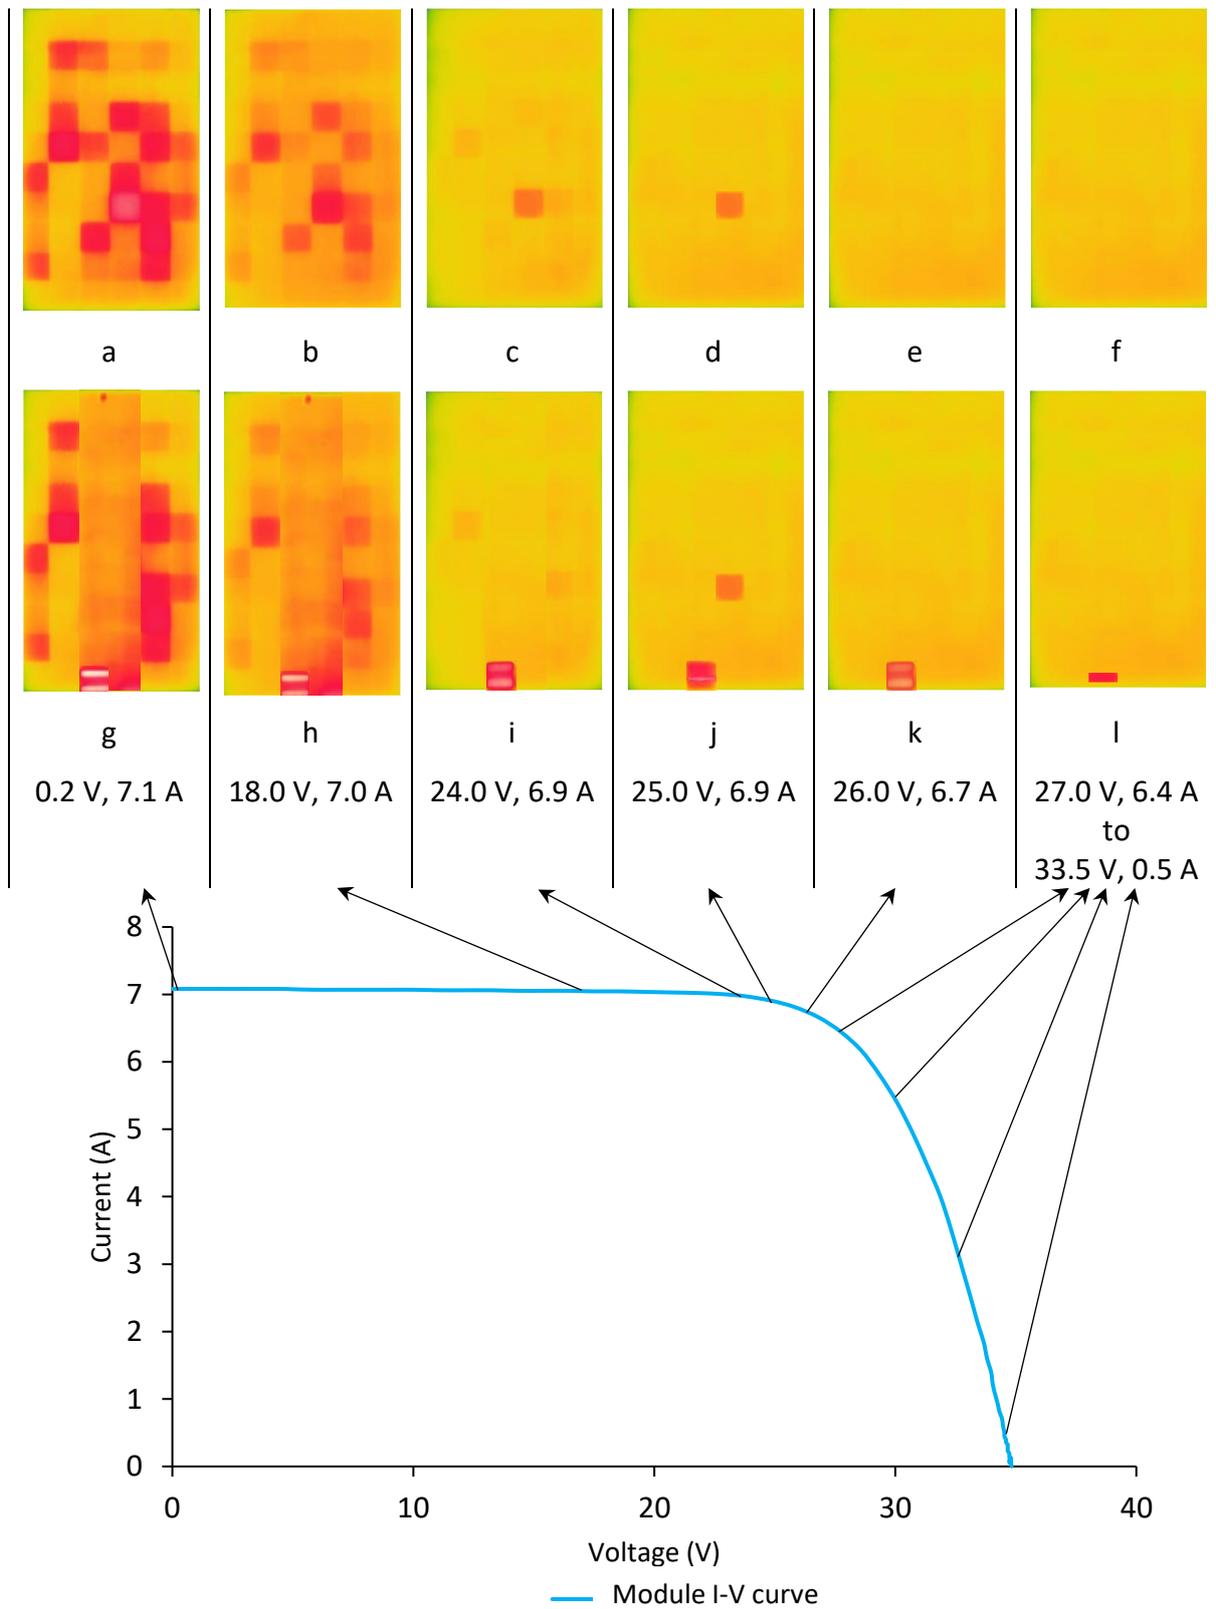
Figure 4.26: Thermal images of the crystalline PV module captured when cell 30 was unshaded (a-f) and shaded (g-l) at different operational current and voltage points of the module.

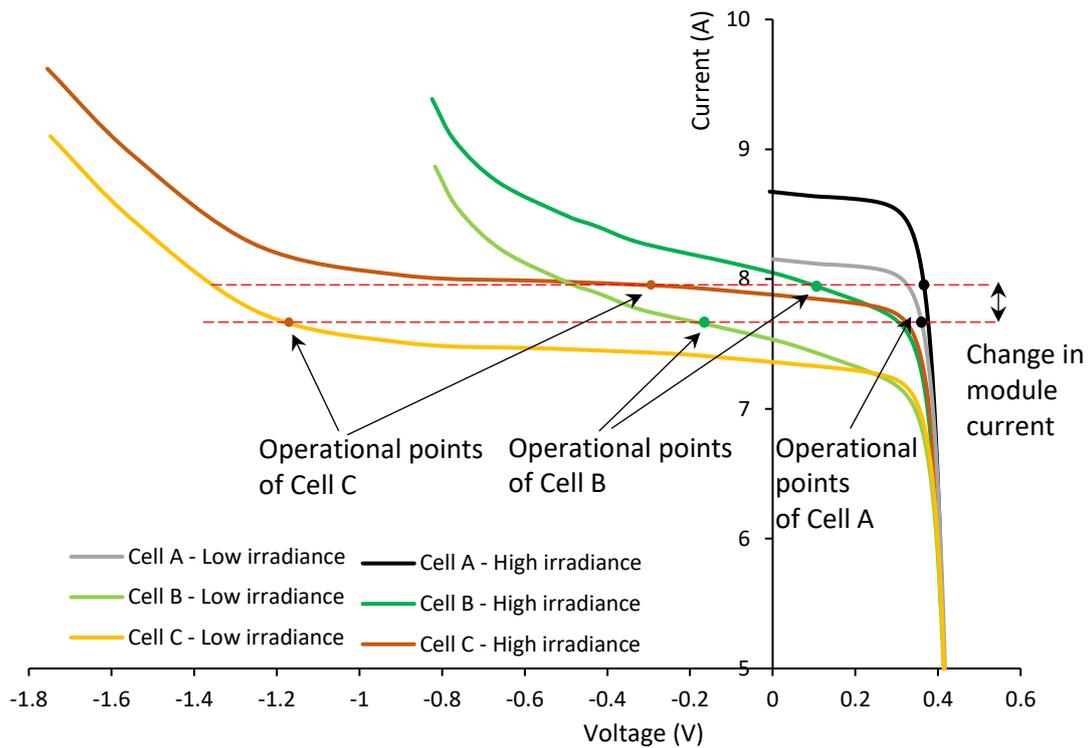
Figure 4.28: I-V curves of three mismatched cells A, B and C indicating a shift in operational voltages when module current changes.

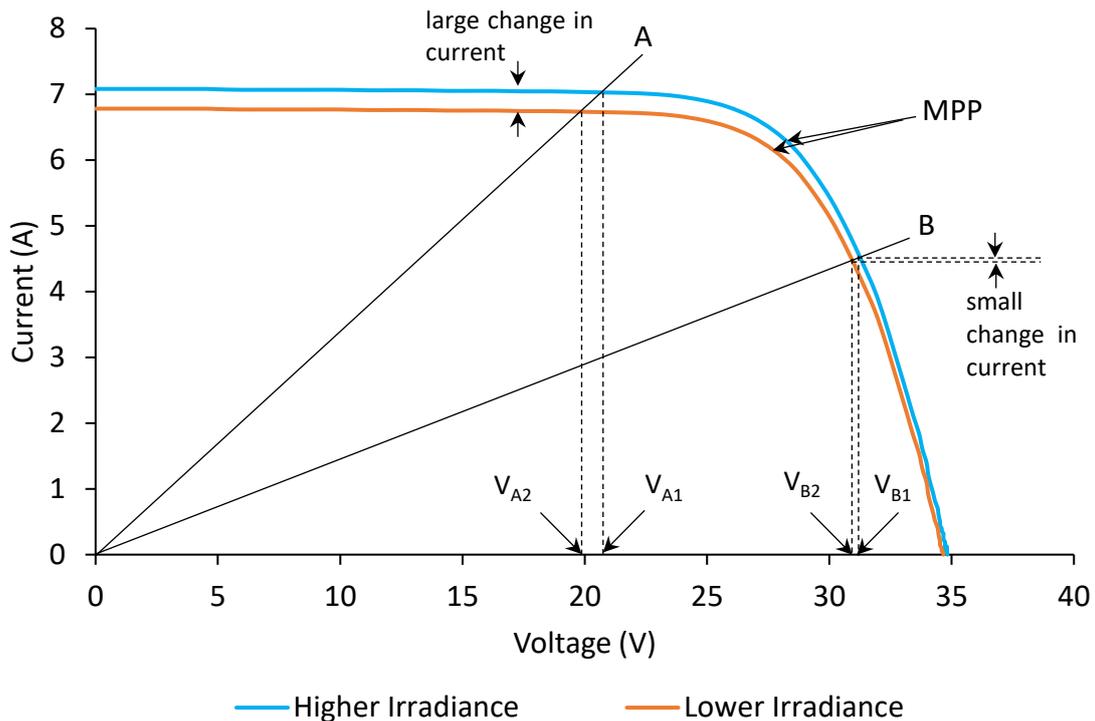
Figure 4.29: I-V curves of a PV module under changing load conditions (load lines A and B) and varying irradiance. The effect of change in irradiance on the operational voltages when the module operates on load lines A and B is indicated.
