Correlation of Thermal images and power degradation of Photovoltaic modules

Submitted in partial fulfilment of
the requirements for the degree of

Magister Scientiae

in the Faculty of Science
at the Nelson Mandela University

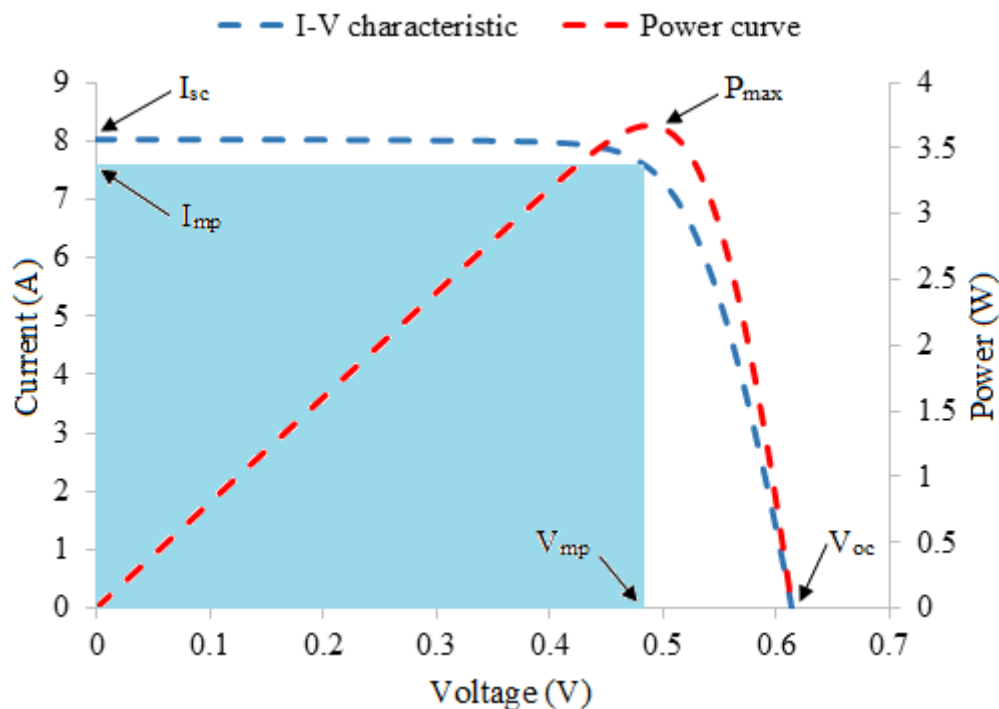
Figure 2-9 shows a typical I-V characteristic of a silicon solar cell together with performance parameters, open-circuit voltage (V_{oc}), short circuit current (I_{sc}), current and voltage at maximum power point, I_{mp} and V_{mp} , and the maximum power (P_{max}). Also shown in the figure is the power curve of the I-V characteristic. A simulator program, PVSIM, [30], was used to show the efficiency of solar cells and modules under different conditions, as shown in some sections that follow. The values of the parameters for the simulated I-V characteristic in Figure 2-9 are listed in Table 2-1.

Figure 2-9: A simulated performance characteristic of a silicon solar cell under standard test conditions.

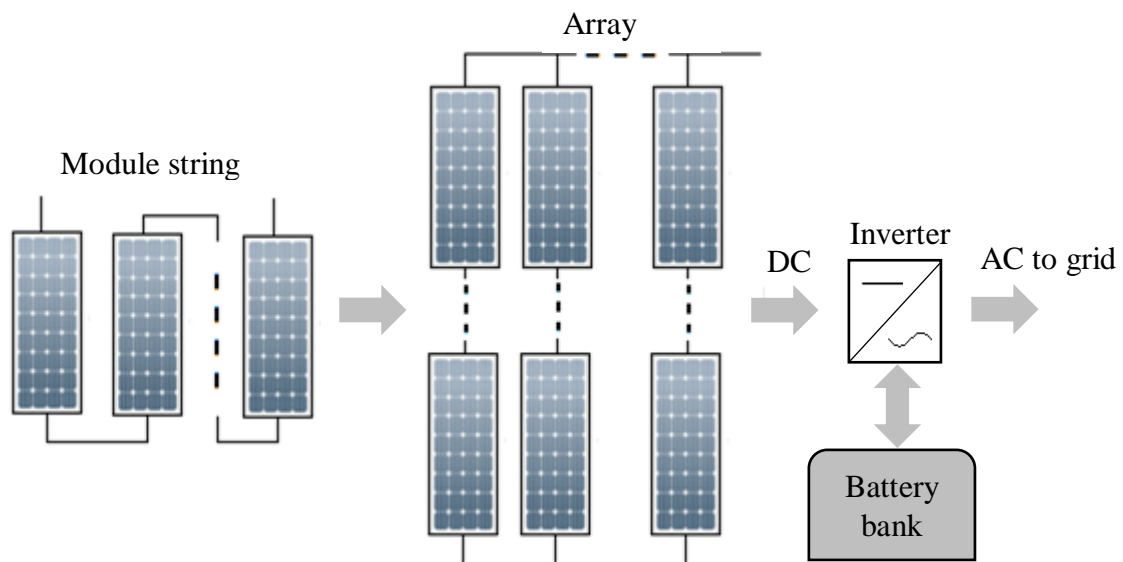
A photovoltaic array is the complete power-generating unit, in PV plants, and consists of several PV modules connected in series, parallel or a combination to achieve the desired power output. Generally, most applications have PV modules connected in series in a string and strings are combined in parallel at a combiner box before being connected to the grid, or load, through an inverter. Figure 2-13 shows a combination of PV modules electrically connected in a typical PV plant layout. In a grid-connected system, the PV generated direct current (DC) is converted to alternating current (AC), by the inverter, and synchronised to the grid, while in stand-alone generators there is no link to the grid but to batteries. The battery bank is charged when the array is generating power and stores energy to be used when the PV modules are not operating, e.g. at night and cloudy weather [1].

Figure 2-13: Typical interconnection of PV module in the field (adapted from [31]).

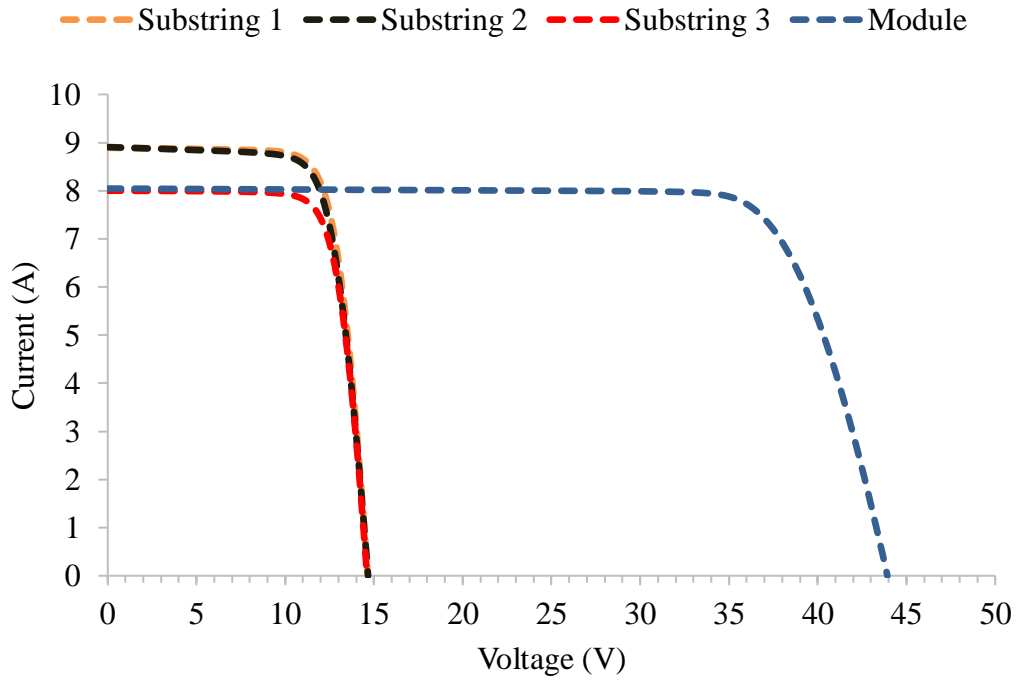
The current mismatch in PV modules has a significant impact on the I-V curves. It alters the shape of the I-V curve [44], indicating the effect on output power of the PV module. Figure 2-19 illustrates the impact of mismatched solar cell substrings on the voltage and current generated by a PV module. The I-V curves for three substrings (with one mismatched), and a substrings combination (the module I-V curve), were simulated using a PVSIM program [30]. The curves, in Figure 2-19 (a) clearly indicate a drop in the current as a result of a faulty substring and the module while V_{oc} of the module equals the addition of the individual substring voltages.

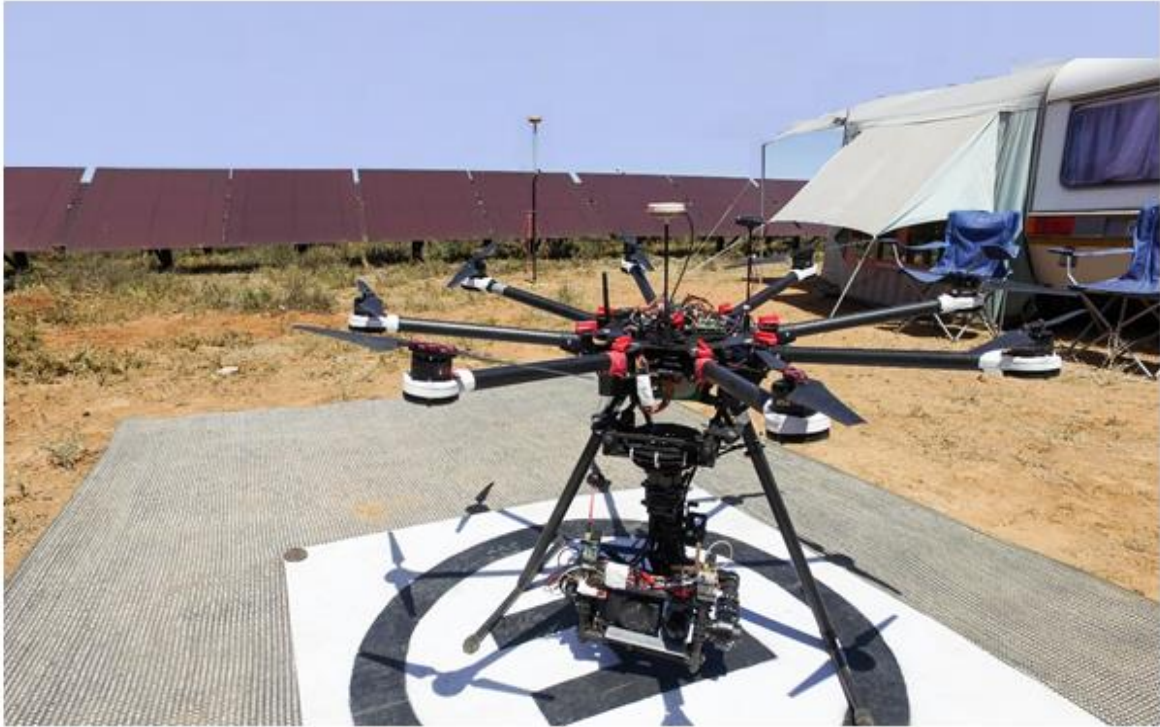
Thermal Infra-Red (TIR) recordings of operating PV modules were obtained with the use of a lightweight camera mounted on a remote-controlled UAV/drone. The camera utilised was a Flir Tau2 640 and enabled simultaneous capturing of TIR and visual images. The camera specifications are listed in reference [53]. Figure 3-2 shows the UAV with integrated IR camera used for the generation of the aerial TIR data.

Figure 3-2: UAV with I-R camera used for monitoring PV module strings at ERIC.

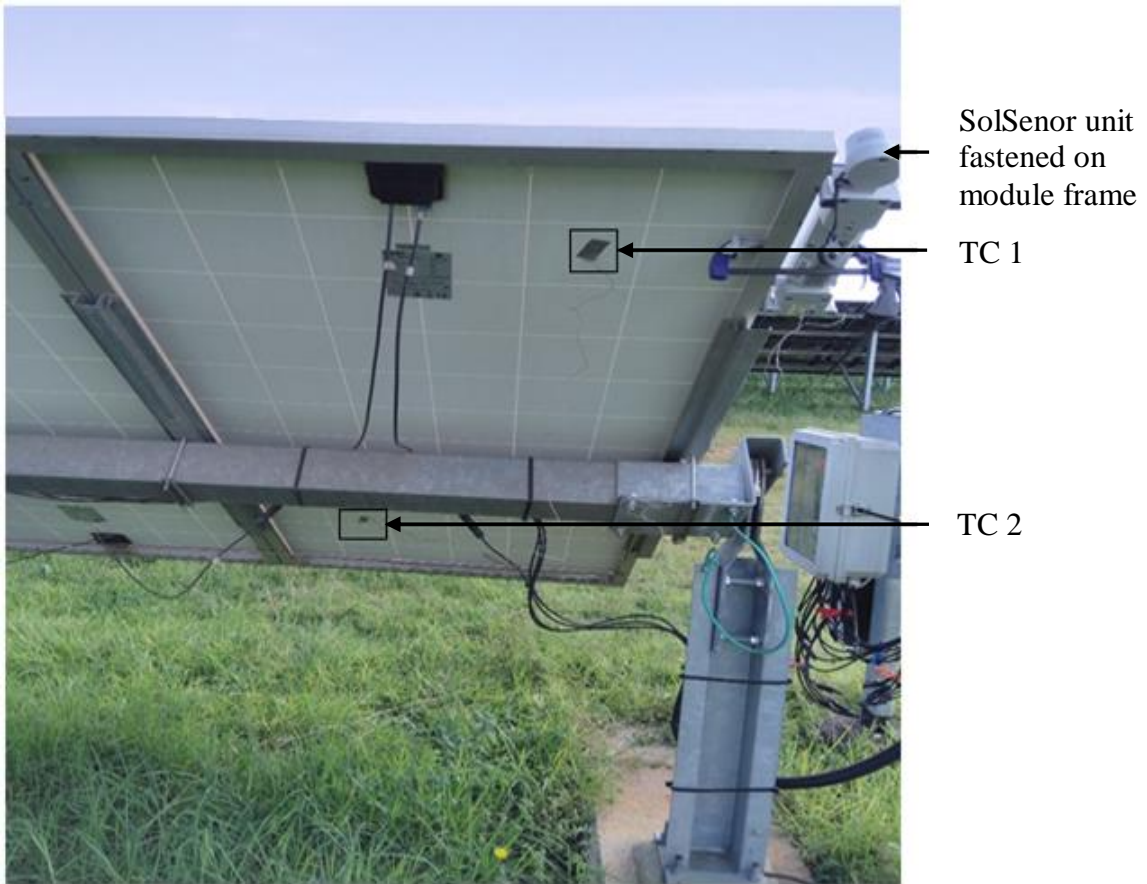
Figure 3-6: Type K thermocouple tips stuck diagonally on the backside of a PV module and a SolSensor unit at same inclination angle as the modules.

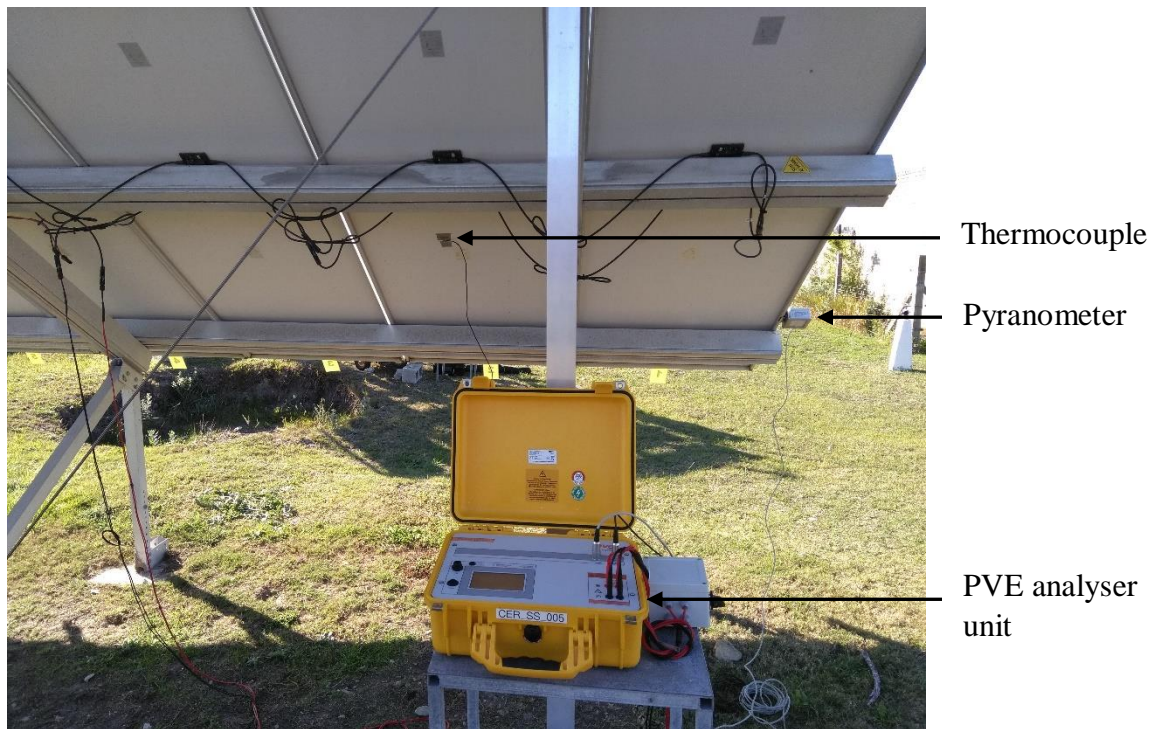
Figure 3-9: I-V measurement equipment set up at ORF.

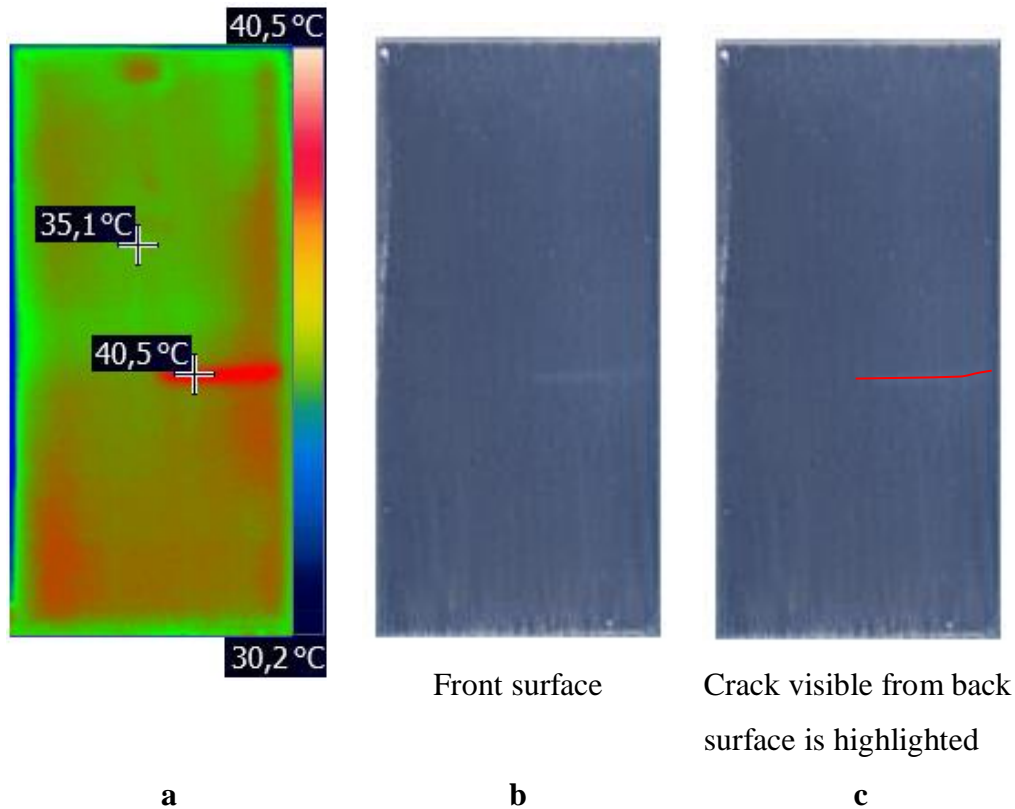
Figure 4-5: Thermal and optical images of the defective module in string A700-Inv17-ST09.

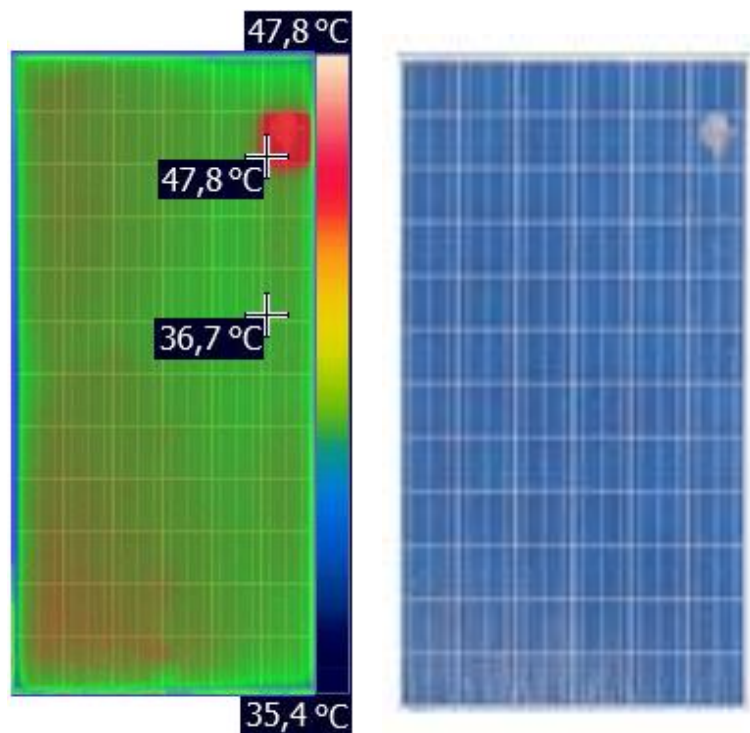
Figure 4-7: Thermal and optical images of a module soiled from bird dropping.

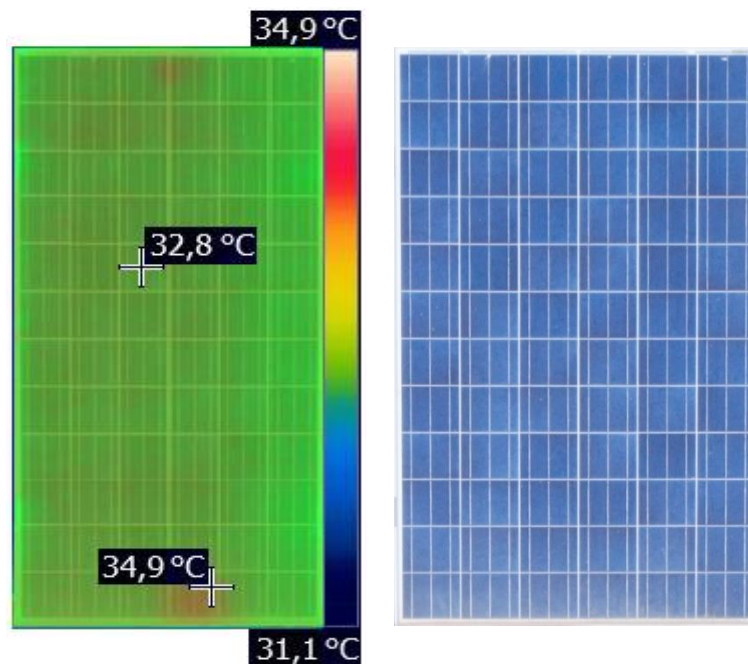
Figure 4-16: Thermal and optical images of a module with a warm cell.

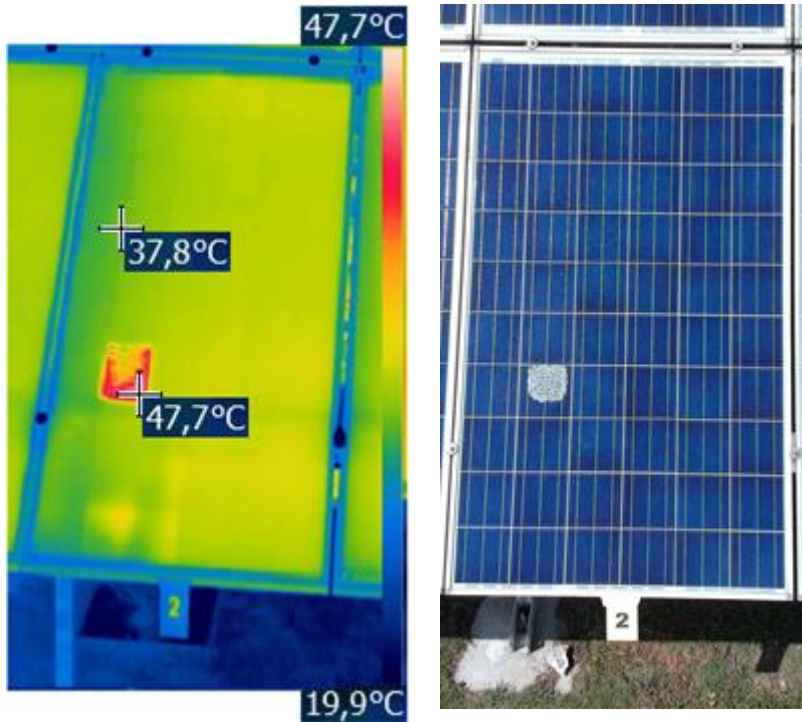
light shading

Figure 4-18: Thermal and optical images of a module with a cell under light shading.
